## Technical Information

20/24 ENU 4020

## Assessment of Cracks on Elastomer Bearings on the Front and Rear Axles (20/24)

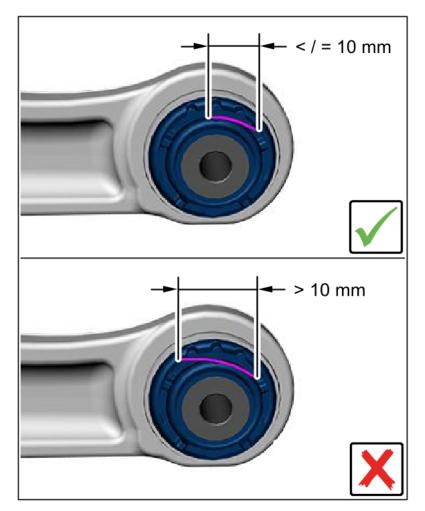
Review elastomer bearing

(*)	<ul> <li>Crack length up to 10 mm/ 0.39 in</li> <li>No customer complaint (noise in the affected area)</li> <li>Bearing bush has no play</li> <li>Replacing the elastomer bearing is not required.</li> <li>End of remedial action.</li> </ul>
(X)	<ul> <li>Crack length exceeds 10 mm/ 0.39 in</li> <li>Customer complains about noises in the area of the elastomer bearing</li> <li>Bearing bush has play</li> <li>Depending on the respective repair concept, either replace the defective elastomer bearing individually or replace the entire component.</li> </ul>
