## TECH TALK - VOLUME 279

### MARCH/APRIL 2024

## TECHNICAL INFORMATION

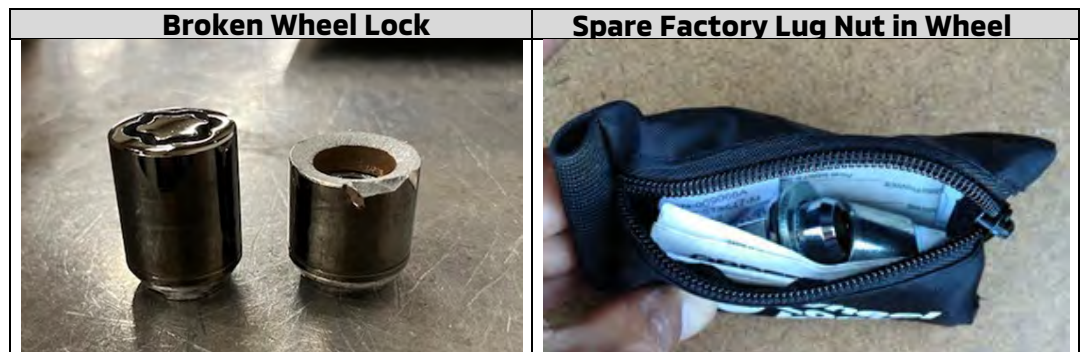
When installing factory spare tire, which is on a steel wheel, do not use a wheel lock to secure the wheel. Due to the steel wheel's thickness being less than the alloy wheel's thickness, more of the wheel stud is exposed. If the wheel lock is installed on the steel wheel, it will bottom out and break when fully torqued. The customer and dealer need to utilize the spare factory lug nut stored in the wheel lock bag.

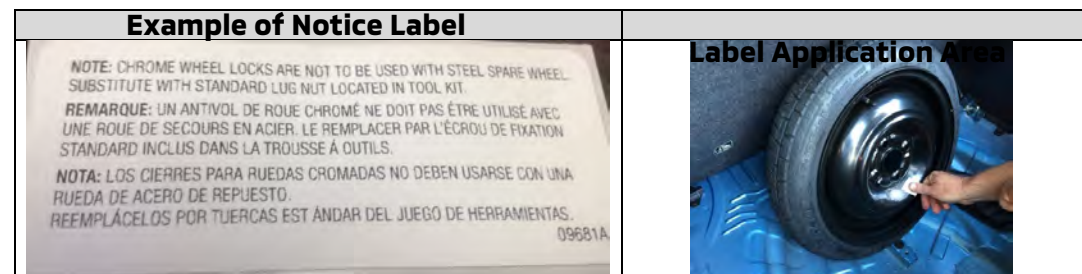
If the wheel lock set is installed prior to dealer delivery, a Notice Label for this condition is already installed on the factory spare tire. If the wheel lock set is installed at the dealer, this Notice Label is included with the kit and must be installed on the factory spare tire.

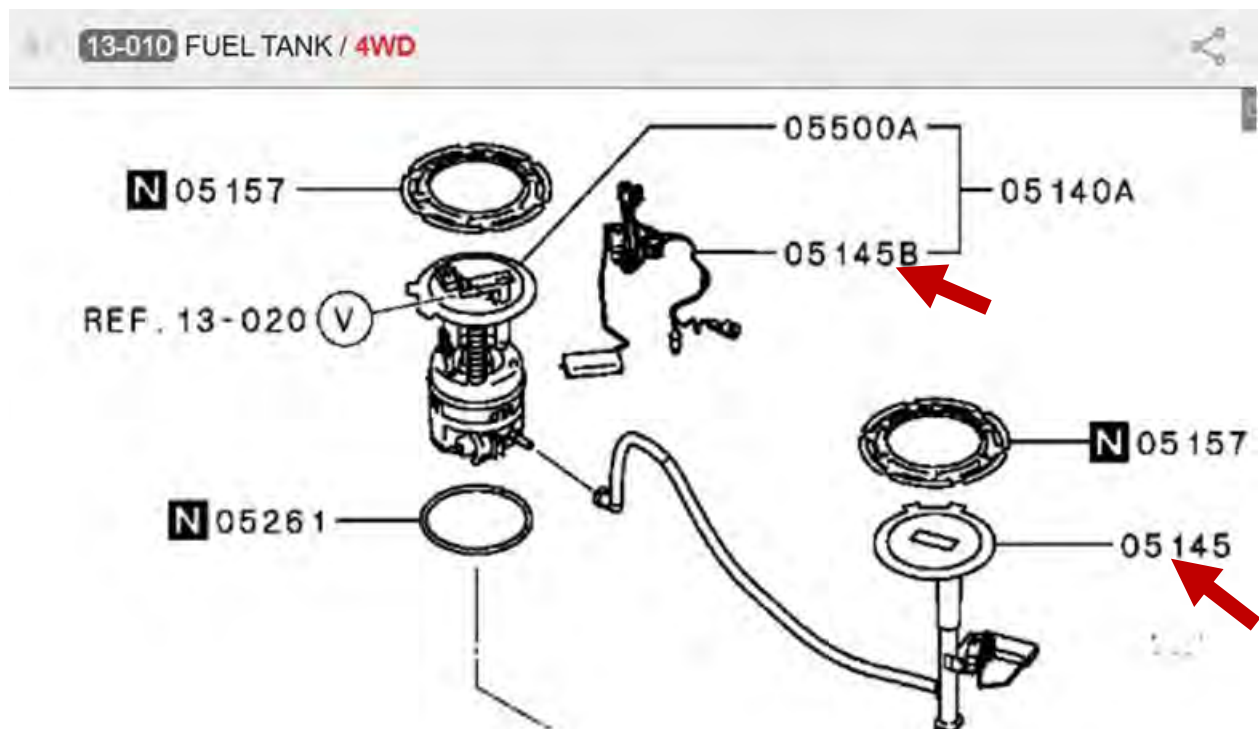
When encountering a vehicle that will not start and has no fuel pressure, before condemning the fuel pump, first do a visual check to verify that there is sufficient fuel in the tank. In certain situations the fuel gauge may display that there is adequate fuel but upon disassembly the tech discovers that the tank is dry. Many times adding fuel results in the vehicle starting as it should, which should direct the tech to checking the level sensor, or sensors if it is AWD. This quick extra step in the diagnostic process could help prevent unnecessary fuel pump replacement and result in a more accurate repair. If a fuel level sensor is faulty, is it not necessary to replace the entire fuel pump as each sensor is available as a separate part. Tech Talk 276 has additional information regarding fuel level sensor diagnostics.

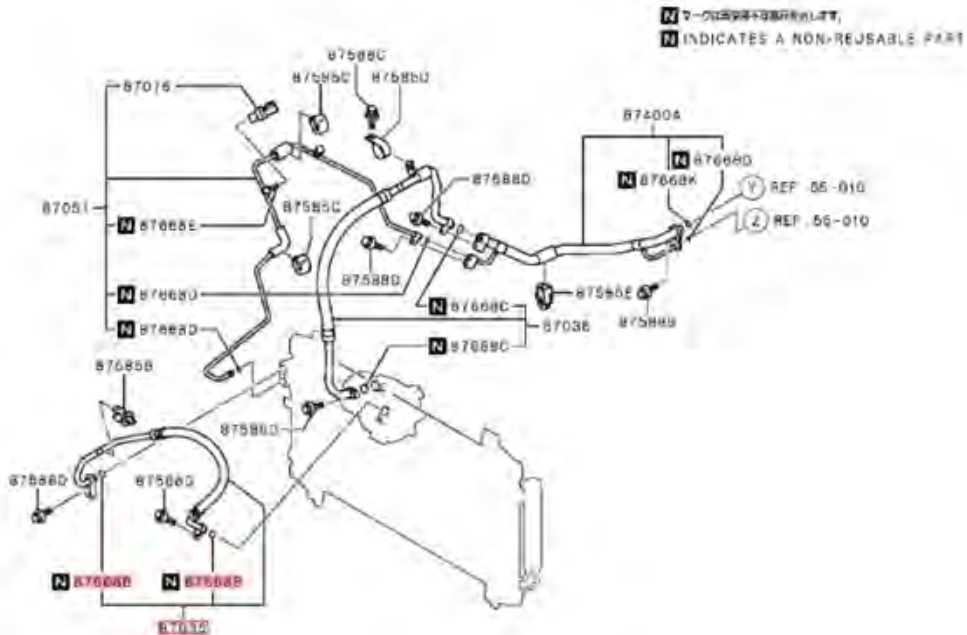
When a refrigerant leak is isolated to the seals at the A/C compressor discharge piping which connects the AC compressor to the Condenser, MMNA asks that technicians replace the seals using updated O-rings 92477W0210P and 92477W0220P.

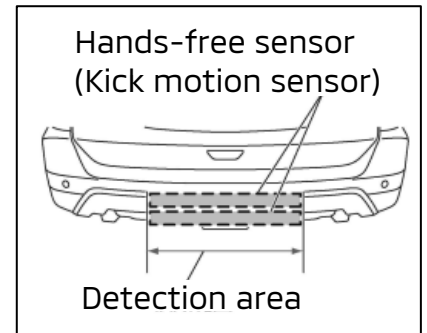
In cases such as those shown in Table 1, the Hands-free sensor may open the tailgate unintentionally. On the other hand, if the KOS (Keyless Operation System) key is far enough away from the car, the tailgate will not open unintentionally in these situations.

If customers claim their tailgate opens unintentionally, please check following items:

- ✓ When this issue occurs, please check if there were any objects within the detection area of Hands-free sensor.
- ✓ Does the customer store the KOS key within hands-free operable range?  
->Refer to 'How to check whether KOS key is within hands-free operable area'.

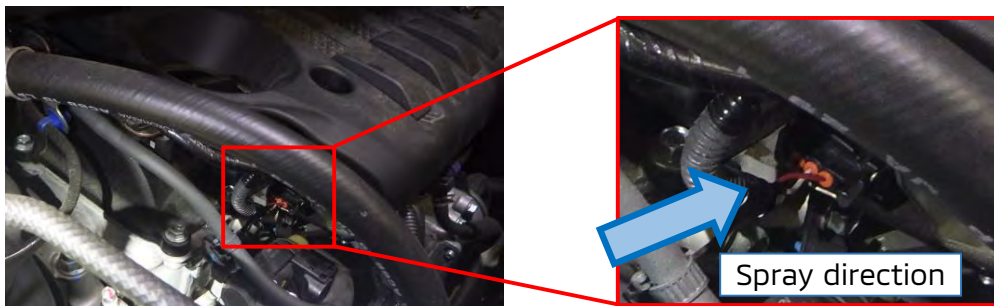
4N14 - Common rail pressure sensor issue due to high-pressure car washing. Worst case scenario: Engine stall, unable to restart.

1. Do NOT splash water in the engine bay. When the underside of the vehicle is washed, please be careful to avoid water contact in the engine bay.

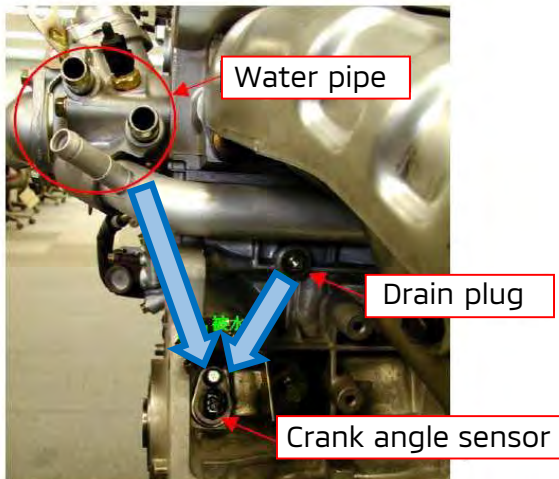
4B1 - Crank angle sensor issue due to spilled LLC during water hose/drain plug removal. Worst case scenario: Engine cannot start.

When the connector is disconnected, please protect it with waterproof material: plastic tape or plastic bag.

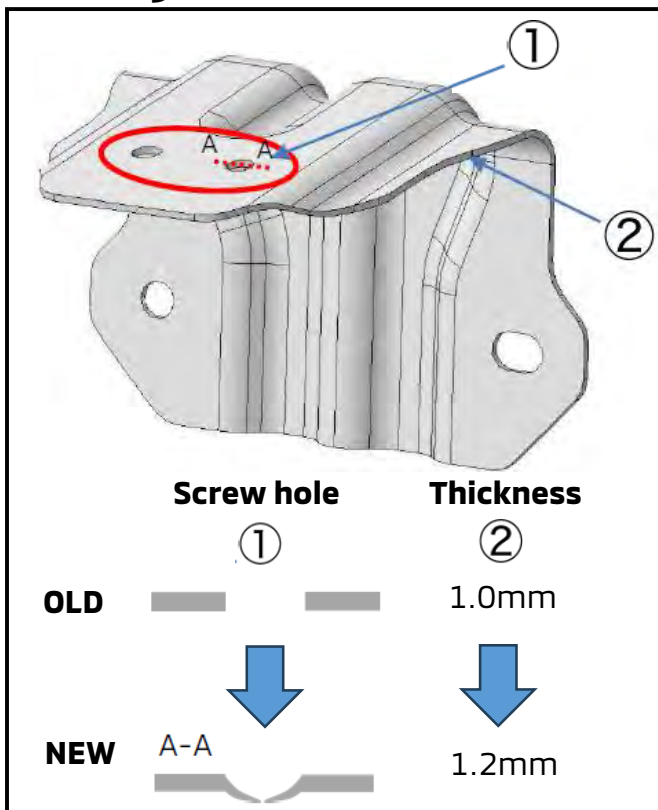
### Part change made to the bracket:

Due to the screw hole structure of the door pull handle bracket, strong opening/closing operations may cause the tapping screw to rotate and loosen, resulting a loose door handle with noise. To prevent this phenomenon from occurring, changes were made to the Bracket on the front left/right doors and specified the tightening torque as shown below.

Part Name	Old Part Number	New Part Number
BRACKET, FR DOOR PULL HANDLE	7222B632	7221AW000P

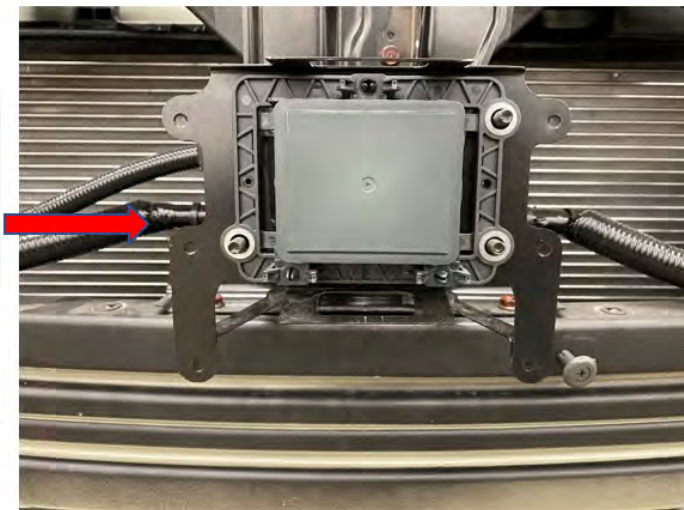
**FRONT VIEW**

The MMNA Warranty Department has noticed a recent rise in claims for the Forward Distance Sensor Bracket on the 2022 and newer Outlander. This bracket is located directly behind the bumper fascia and serves as the mount for the Forward Distance Warning Sensor. When this bracket is installed, it is secured in a way that will maintain position for the life of the vehicle and will not fail, fatigue, and/or experience misalignment of the sensor without outside influence such as impact to the front bumper. This damage is not a warrantable condition. When diagnosing the vehicle, shine a light down beside the hood latch to the location of the bracket making sure to view each side thoroughly. Compare those findings to that of a vehicle known to be in proper working order. In addition, check the vehicle thoroughly for evidence of front impact damage, including but not limited to, damage to the paint, dents, body misalignment, etc. Lower impact damage may not be easily identifiable with damage to the fascia thus the need to thoroughly examine the bracket itself as shown in the images below. It's important to explain to the customer the reason for this being a non-warrantable condition for their awareness. Should the Dealer and/or the DPSM feel that this is a loyal Mitsubishi customer and would like to offer goodwill, contact your DPSM, and submit a claim by placing the claim in PWA-Hold for final approval adhering to Goodwill Policy for review.

Verify the front plate and its components are fully intact and in alignment vertically and horizontally. Ensure no cracks, dents, bends and/or buckles are present.
