## LOW SPEED DRIVEABILITY – 2.0L/P4 AND 3.0L/P6

### Technical Description:

- PCM, P052A-00, P054A-00, P0014-71 exhaust camshaft position timing codes might possibly be set.

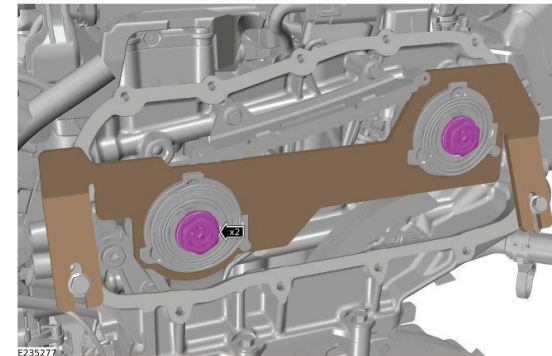
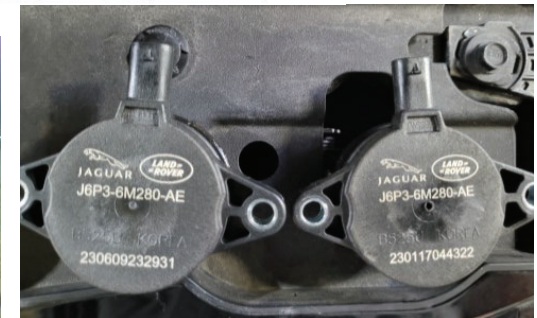
303-01B: Engine - INGENIUM I6 3.0L Petrol, Upper Timing chain

- When using the workflow for the above codes. the VVT solenoids should be checked along with the VVT bolts for any damage.
- Instructions are to replace both solenoids and bolts.
- Please open an EPQR if you have any vehicles with this condition.
