SRS SYSTEM FAULTS DUE TO AFTERMARKET DONGLES FITTED

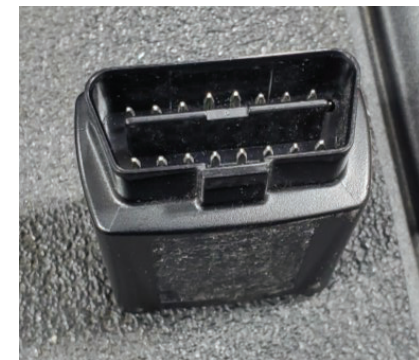
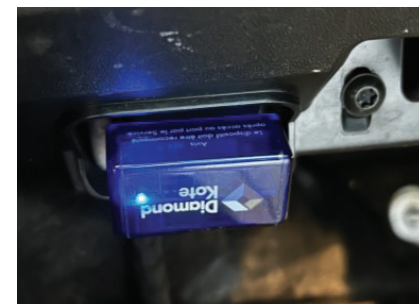
- This may be caused by aftermarket dongles being installed in the Diagnostic Link Connector (DLC).

- Many different aftermarket electronic devices found installed into the DLC have set spurious faults in the SRS module.
- When diagnosing a customer concern, please check for non approved aftermarket electronic devices installed into the vehicle electrical system.
- If not present at the time of diagnostic work being performed, ask the customer if such devices are used.
