Service Bulletin

Bulletin No.: 23-NA-020

Subject: Oil Leak from Front of Engine

Brand:	Model:	Model Year:		VIN:		Engine:	Transmission:
		from	to	from	to		
Chevrolet	Corvette	2023	2023	—	—	5.5L (RPO LT6)	—

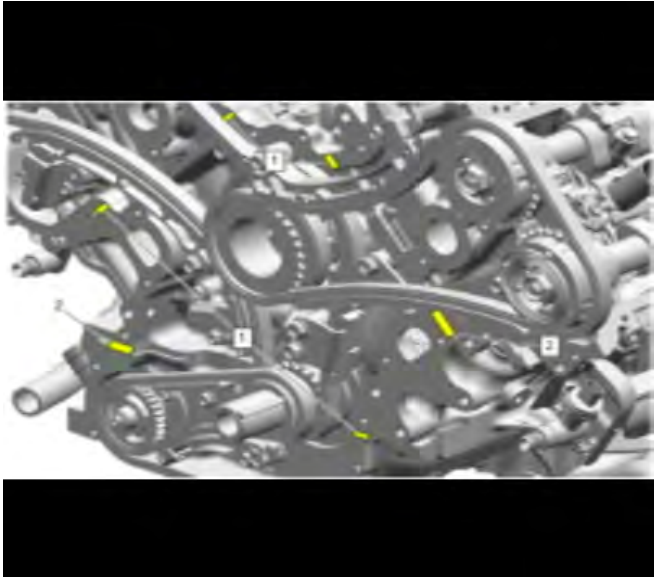
Involved Region or Country	North America, Europe, Israel, Palestine, Japan, Thailand, Australia/New Zealand
Condition	Some customers may comment that there is a visible engine oil leak coming from underneath the middle of the vehicle. During inspection, some technicians may notice that there is a small oil leak coming from the engine front cover area.
Cause	<div style="text-align: center;">

</div> <p style="text-align: right; font-size: small;">6267588</p> <p>This condition may be caused by improper front cover bolt torque or inadequate sealer adhesion at one of the six T-Joint locations.</p> <ul style="list-style-type: none"> – The oil leak can be found at the T-Joint location where the cylinder head meets the engine block, or at one of the other T-Joint locations (shown in yellow) in the graphic above.
Correction	To correct this condition, it will be necessary to install new front cover gaskets and follow the revised RTV sealing procedure as noted below.

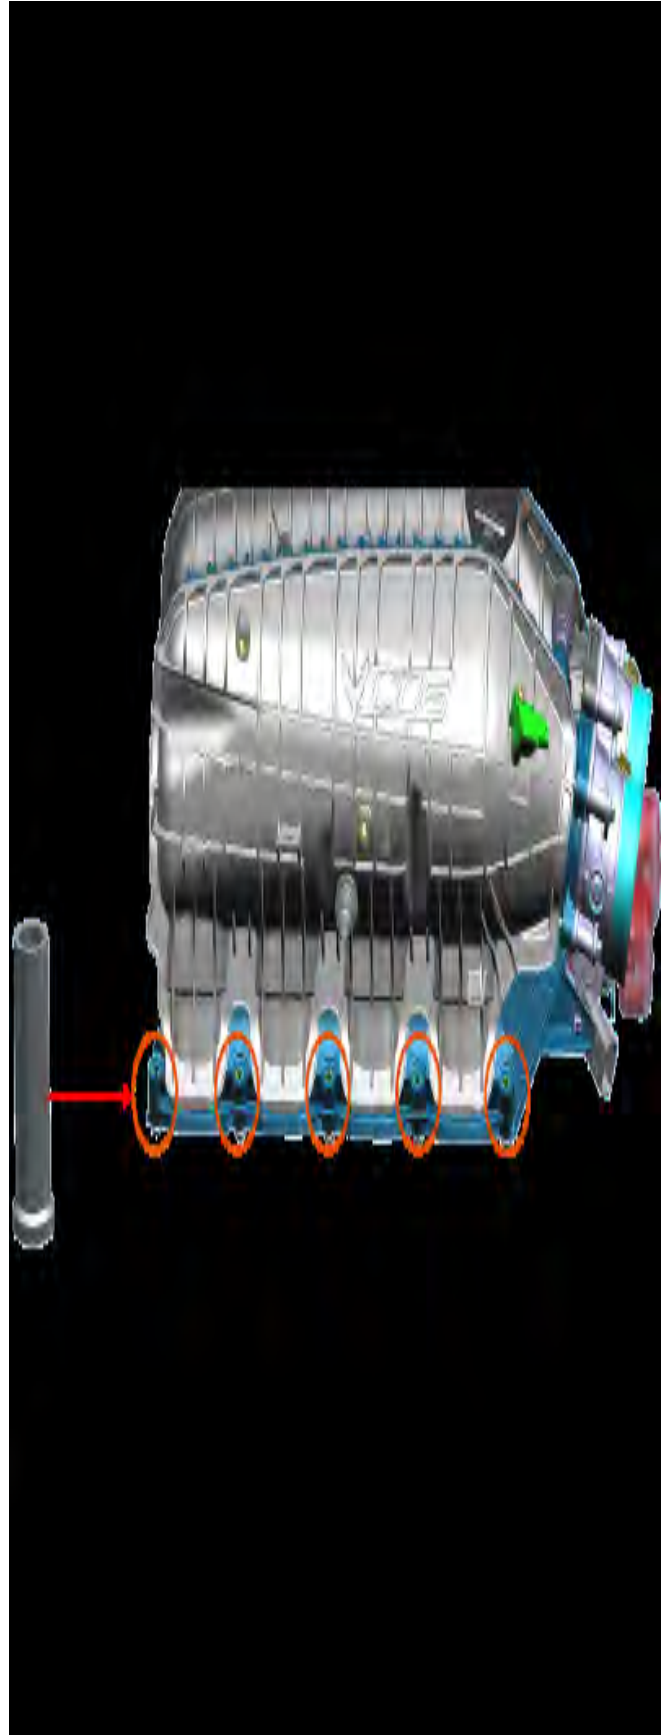
Intake Assembly left hand side shown (right side similar).

Important: When performing this service procedure, the intake manifold needs to be removed and reinstalled. During installation, ensure that all 10 compression limiters are installed and present in their correct positions before fastening the intake to the cylinder head.

Important: Ensure all front cover bolts are torqued in proper sequence and to specification.

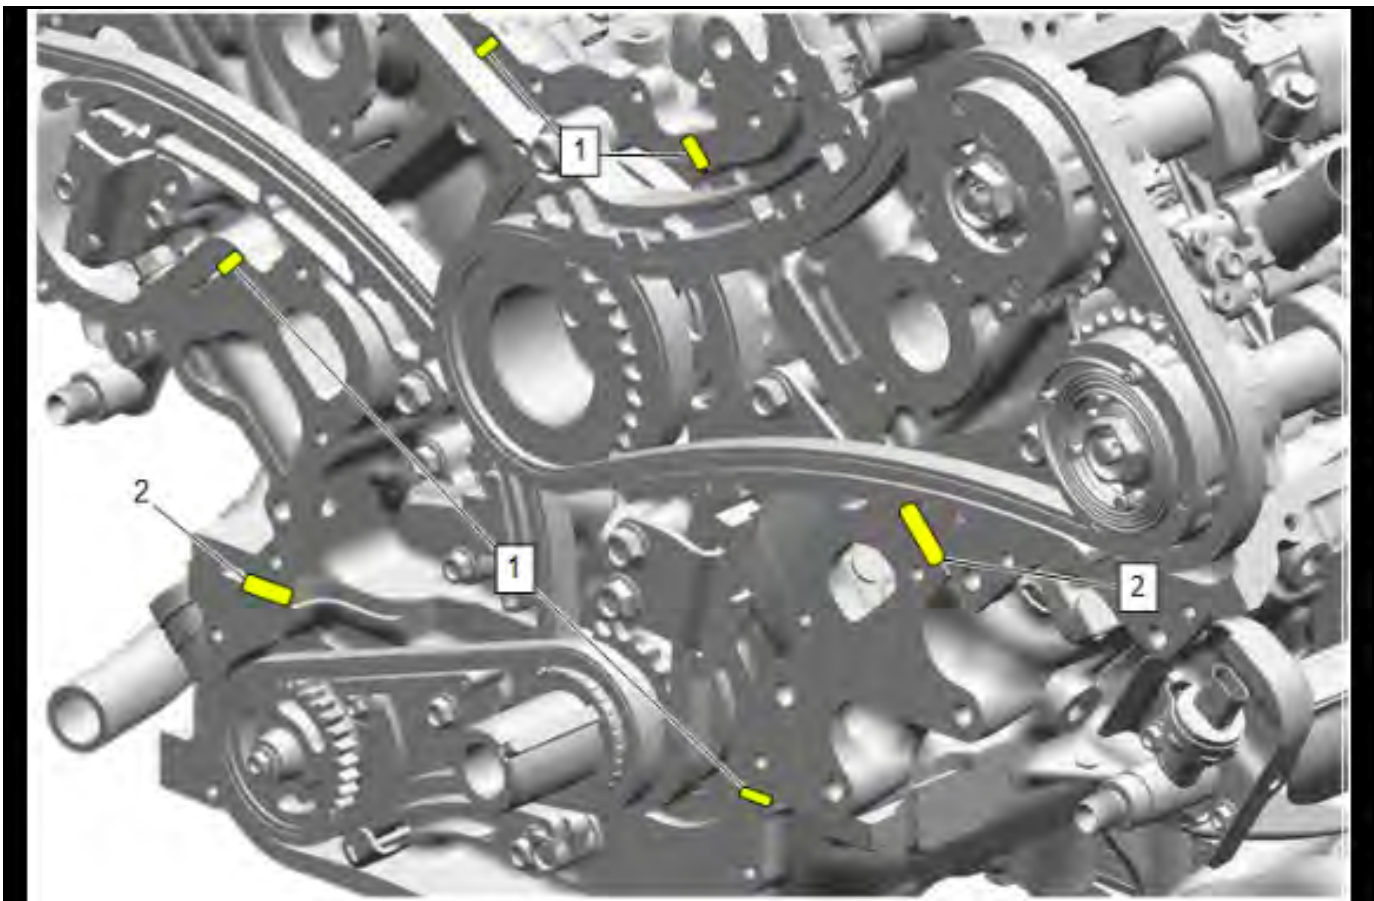
6002788

Important: Application of the RTV has changed. Please refer to the picture and steps below for proper RTV application.

Note: The sealing surface must be clean and free of contaminants prior to applying the RTV sealant. Do not touch the sealing surface once it has been cleaned.

1. Clean the sealing surface at the T-Joints (1 and 2) with low VOC brake cleaner, then wipe dry with a clean lint-free cloth.

Note: Do not allow RTV to skin over. The engine front cover gaskets and engine front cover must be installed within 8 minutes of RTV application.

2. Apply a 5 mm wide x 15 mm bead of sealant to the 4 T-Joints (1) between the cylinder head-to-engine block and the engine block-to-lower crankcase.
3. Apply a 5 mm wide x 25 mm bead of sealant to the 2 T-Joints (2) between the cylinder head-to-engine block and the engine block-to-lower crankcase.
