# Technical product information

<b>Topic</b>	Rear screen sunblind operational issues
<b>Market area</b>	Australia E04 Bentley rest Asia and Australia (6E04),China 723 Volkswagen (Anhui) Automotive CO (6723),China 796 VW Import Comp. Ltd (Vico), Beijing (6796),Germany E02 Bentley rest Europe (6E02),Japan E03 Bentley Japan (6E03),Korea, (South) E08 Bentley South Korea (6E08),United Arab Emirates E06 Bentley Middle East and Africa (6E06),United Kingdom E01 Bentley UK (6E01),United States E05 Bentley USA and rest America (6E05)
<b>Brand</b>	Bentley
<b>Transaction No.</b>	2070643/4
<b>Level</b>	EH
<b>Status</b>	Approval
<b>Release date</b>

### New Flying Spur

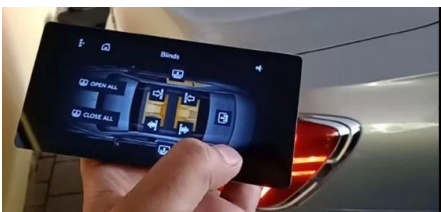
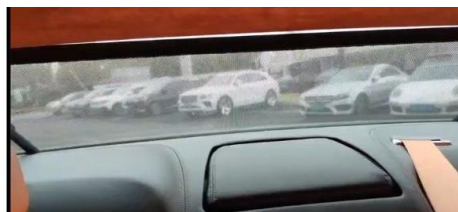
Figure 1

- Attach a clear video and photographs of the failure mode to a new or existing DISS query (see examples in Figure 1)

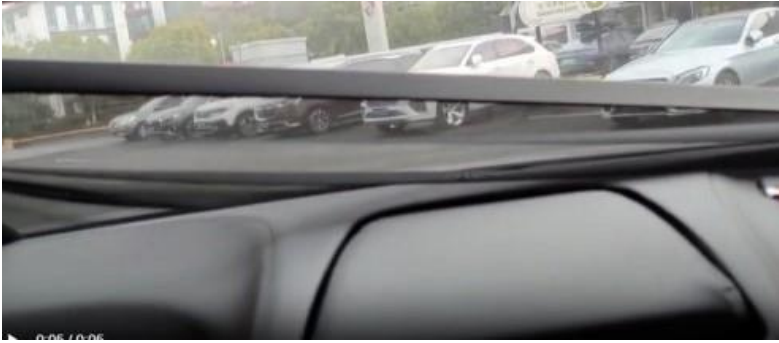
Figure 3

Rear blind is detached on one side (Figure 3)

**NOTE: In this scenario (rear blind detached) the rear blind assembly must be replaced**

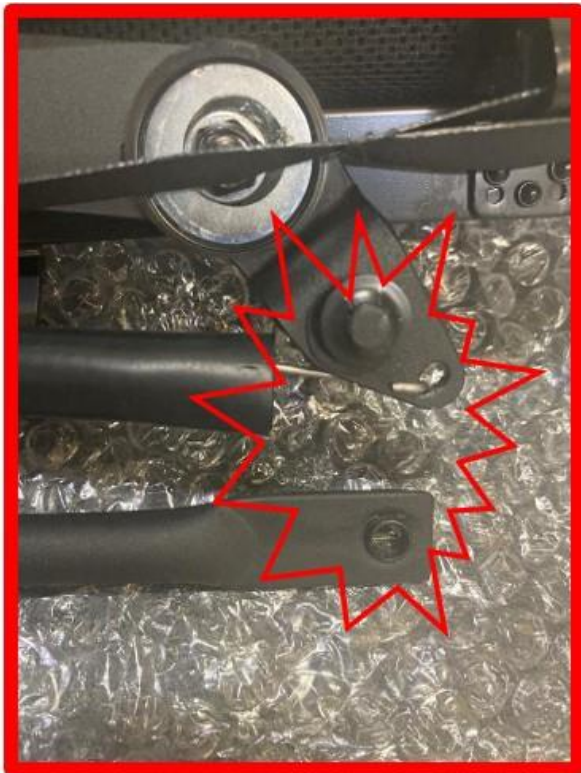
- Referring to Figure 4 - Confirm if the rivet and star washer is fitted / secure

NOTE: Figure 4 shows the rivet and star washer detached

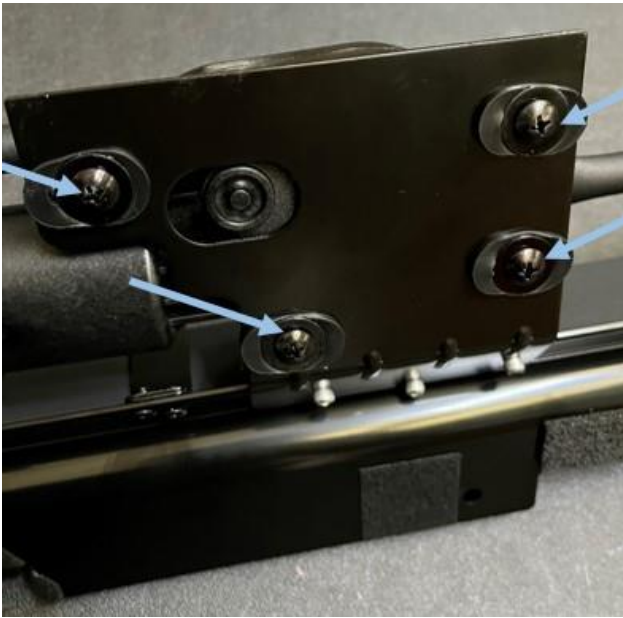
Gearbox screws loose (Figure 5 and Figure 6)

**NOTE:** Figure 5 and Figure 6 show loose gearbox screws (not secured to 2.5Nm)

The following may also be evident which confirms the gearbox screws are loose:

Witness marks on the mounting surfaces

Gap(s) between the motor and mounting plate

**NOTE: Should the gearbox screws be loose the rear blind must be replaced - DO NOT attempt to secure the fixings**

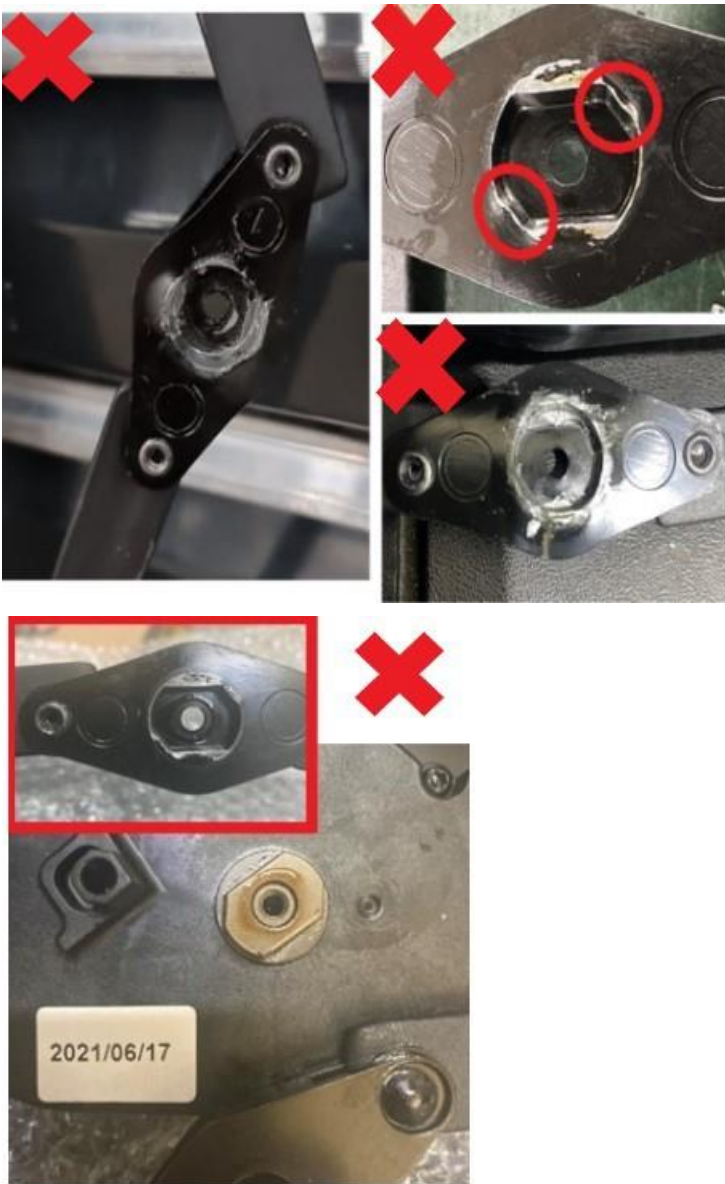
- Referring to Figure 8 - Remove the rotator plate

In the event the rotator plate is NOT OK as shown in the examples in Figure 8, the operative should replace the complete blind assembly

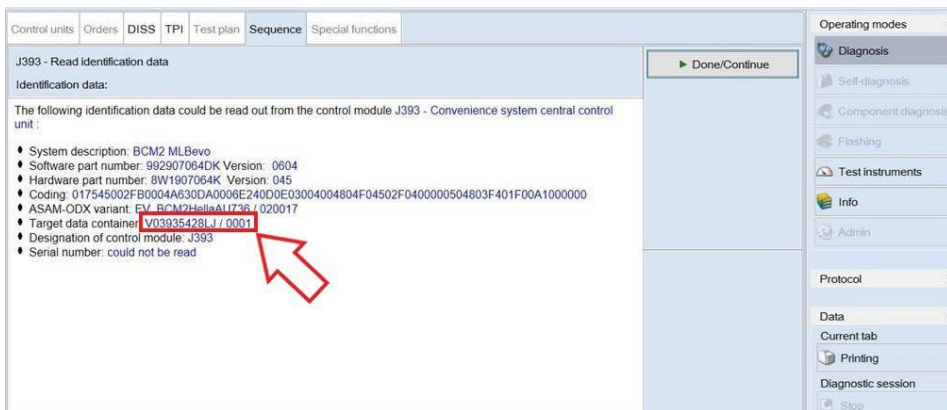
Figure 16

Should the software version be **ZDC V03.935.428.LJ** (Figure 16) the software is at the latest level the operative should refit the rear parcel shelf as Rep.Gr 70

In the event the software version is **V03.935.378.NW** please conduct the software update instructions to completion
