Service Campaign Bulletin

Campaign No. 2023090009, March 2024

SUBJECT: **Model EQS (297 platform)**
Model Year 2022-2023

Inspect Front Left and Right Wheel Well Reinforcement

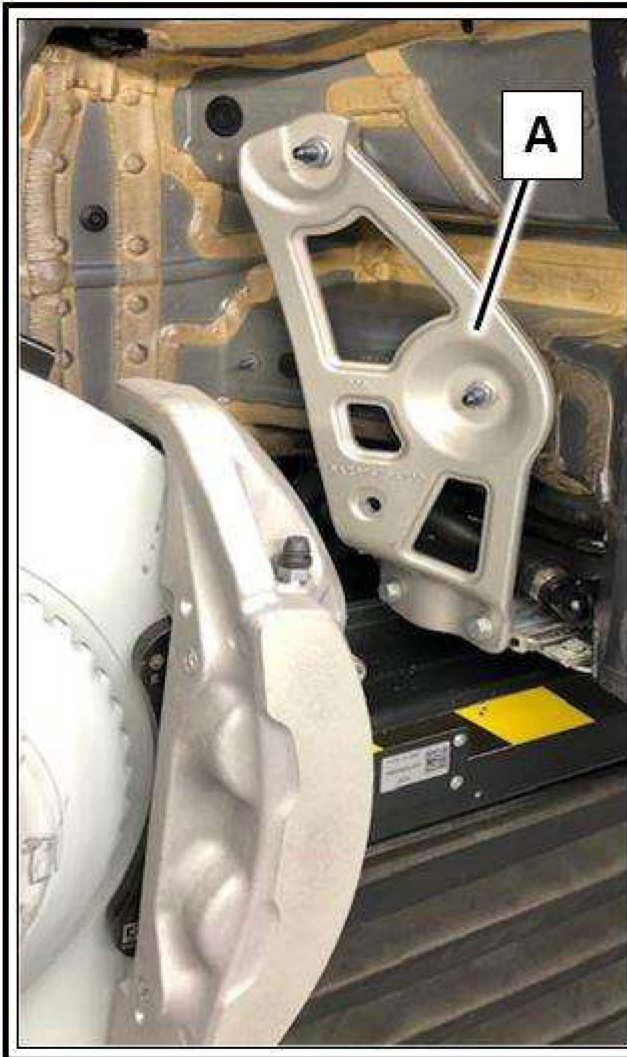
Figure 1, (Left wheel well)

Mercedes-Benz AG ("MBAG"), the manufacturer of Mercedes-Benz vehicles, has determined that on certain Model Year ("MY") 2022-2023 EQS (297 platform) vehicles, the front left and right wheel well reinforcement may be missing. An authorized Mercedes-Benz dealer will check the front left and right wheel well reinforcement on the affected vehicles, and retrofit, if necessary.

1. Lift vehicle on vehicle lift.
i For basic data, see AR00.60-P-1006A.
2. Remove center section of lower engine compartment lining.
i For basic data, see AR61.20-P-1105EQS.
3. Visual check if reinforcement is installed in **both** left and right front wheel wells (**A**, Figures 1 and 2).
 - a. Reinforcement on wheel well (A) **not present**. Carry out **work procedure**.
 - b. Reinforcement on wheel well (A) **present**. **End measure**.

1. Remove front wheel and tire assembly from affected side.
 For basic data, see AR40.10-P-1102A.
 2. Remove rear section of front fender liner from affected side.
 For basic data, see AR88.10-P-1301EQS
 3. Retrofit reinforcement on wheel well as shown (**A, Figures 1 and 2**) on the affected side(s).
 Tighten screw with 30 Nm torque.
 Tighten nut with 30 Nm torque.
 4. Assemble in reverse order.
-
