Technical product information

| Topic | HVAC refrigerant leakage suspected or reports of a damp/musty smell within the cabin - Diagnosis guidelines | | | |
|---|---|--|--|--|
| Brand | Bentley | | | |
| Transaction No. | 2069806/5 | | | |

HVAC refrigerant leakage suspected or reports of a damp/musty smell within the cabin - Diagnosis guidelines

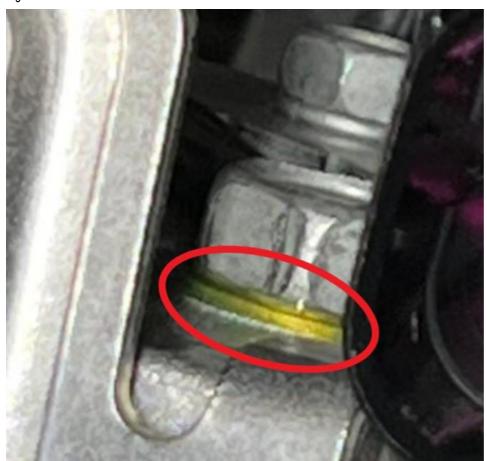
Figure 1

please refer to the examples shown below (Figures 1,2 and 3) of leaks found on the HVAC compressor

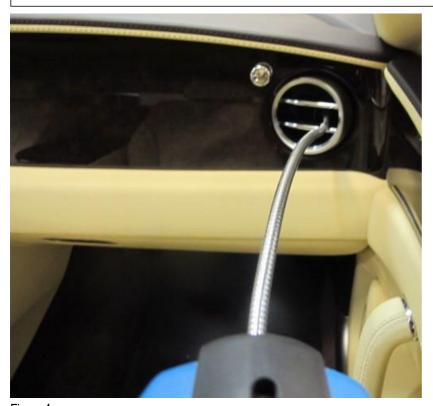
Figure 4

CAUTION: In the event the HVAC sniffer tool traces a HVAC leak from any of the outlets (Figure 4)

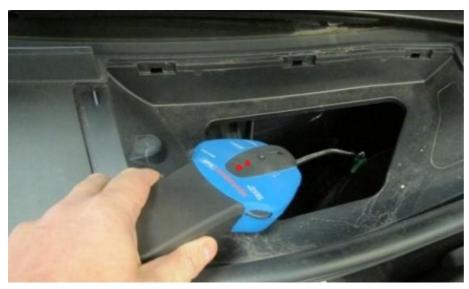
Figure 5

A complaint is received that refrigerant is evident within the cabin the operative MUST first ensure that a leak is not evident within the plenum chamber or around the centre console (Figures 5 and 6) as refrigerant could be leaking into the plenum chamber/cabin and recirculated back into the cabin as this could lead to misdiagnosis and/or incorrect part replacement
