Technical product information

Topic	New Continental GT and GTC - Window drop glass operation
Market area	Australia E04 Bentley rest Asia and Australia (6E04),China 723 Volkswagen (Anhui) Automotive CO (6723),China 796 VW Import Comp. Ltd (Vico), Beijing (6796),Germany E02 Bentley rest Europe (6E02),Japan E03 Bentley Japan (6E03),Korea, (South) E08 Bentley South Korea (6E08),United Arab Emirates E06 Bentley Middle East and Africa (6E06),United Kingdom E01 Bentley UK (6E01),United States E05 Bentley USA and rest America (6E05)
Brand	Bentley
Transaction No.	2070497/8
Level	EH
Status	Approval
Release date

New Continental GT and GTC

Retailer glass reset procedure for GT/GTC

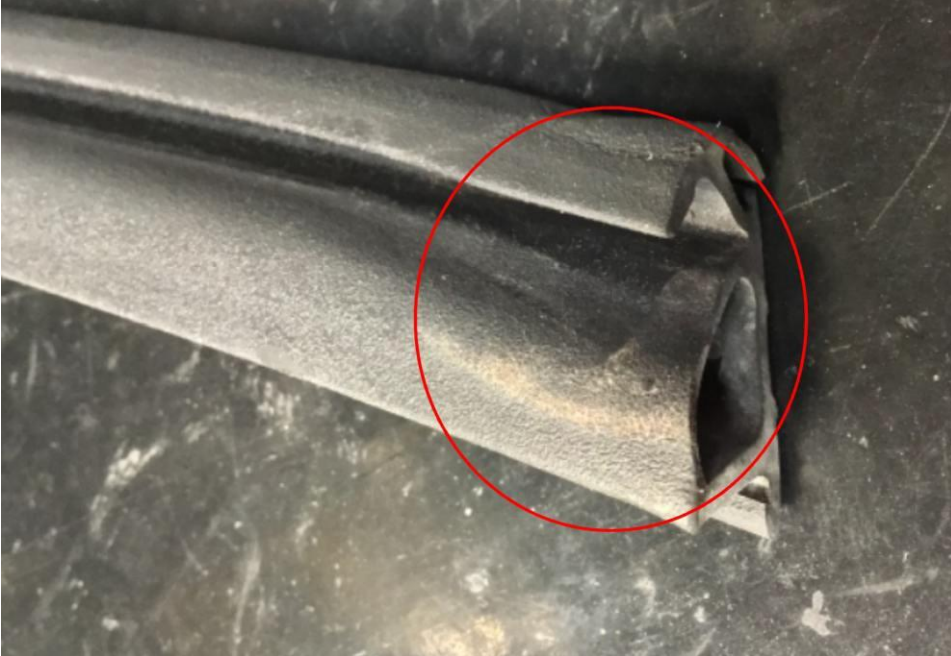
Figure 7

- Damage
- Splits
- Tears
- Misalignment
- Incorrectly fitted / located
- Drop glass seal deformation (see Figures 7 and 8 as examples)

NOTE: Any issues found with the window seals must be rectified before conducting the remaining steps

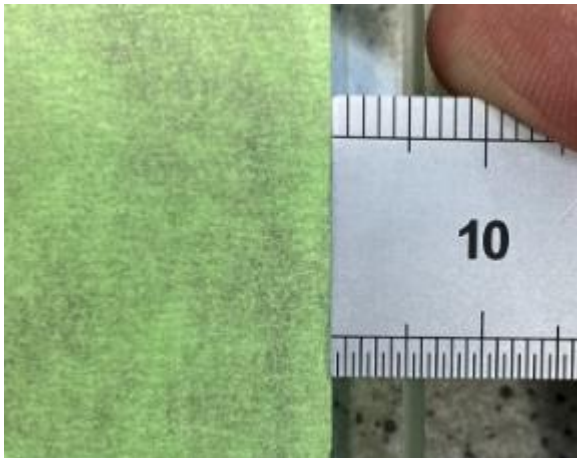
Example of incorrect fitment:
10mm intrusion into division bar seal not achieved. Only 6mm seen, front and rear side glasses will be too far rearwards, potentially clash condition between rear of rear glass and cant rail/roof seals

When reinstalling front drop glass ensure tape is applied at 10mm from front edge and align this with the previously set quarter glass division bar.

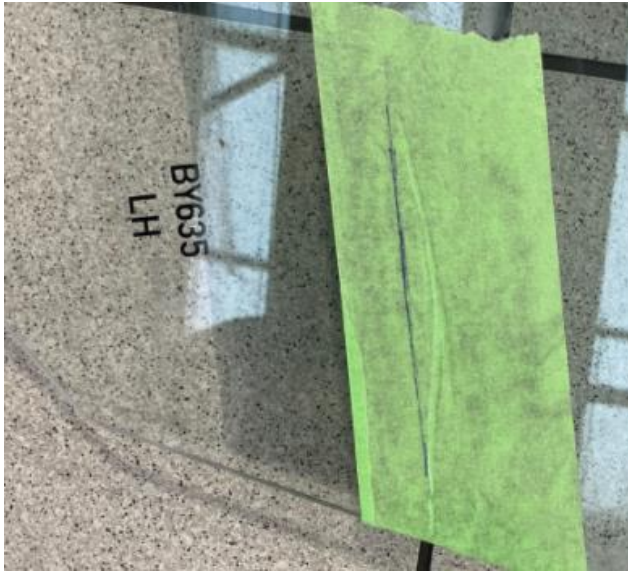
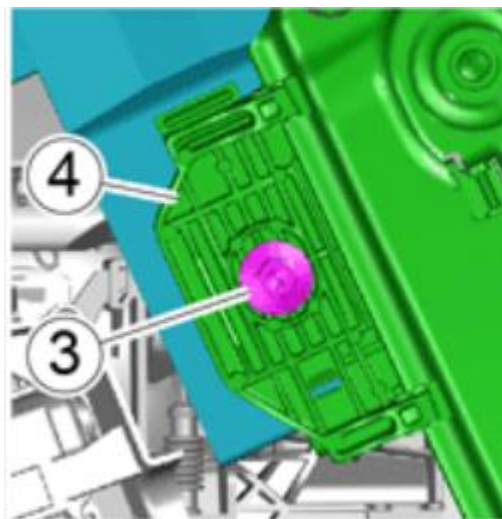
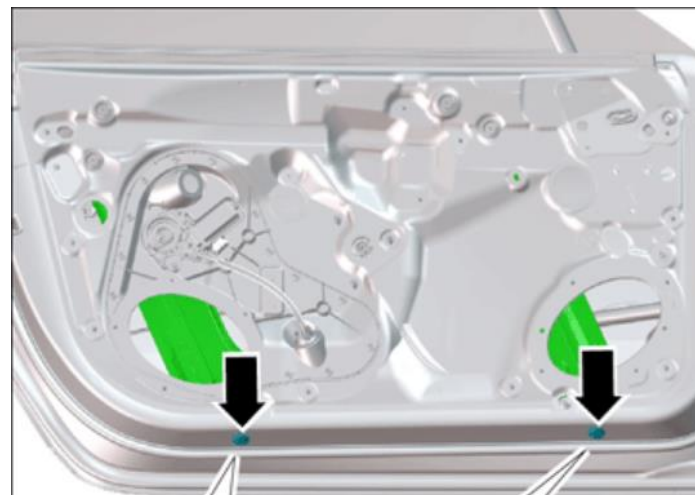
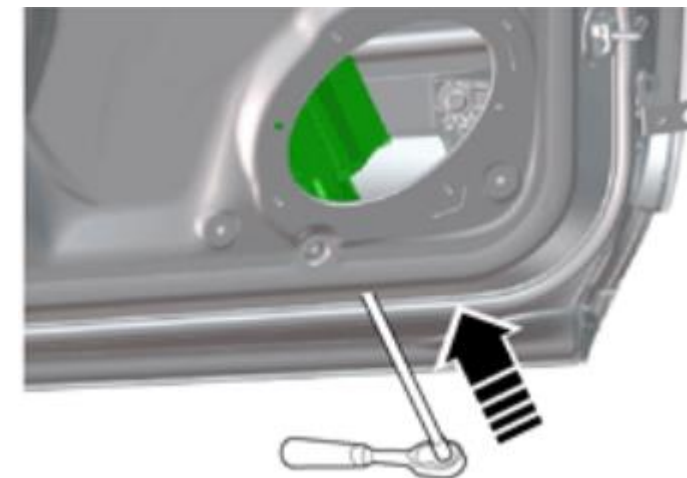
Example: Front drop glass Z axis not adjusted correctly. Bottom of tape was level with waist rail seal, after slackening pinch bolt (3 in bottom left image) front drop glass lowered 14mm to where pen marked line is.

Z-axis adjusters (bottom middle and right images) had not been used, pinch bolt had been slacked and glass lifted out of the regulator to achieve specification. This has a knock on effect of altering the 10mm division bar intrusion seen in previous slide as glass is loose and can be accidentally moved in X-axis.

This also creates a risk that the window will bottom out on the cant rail seals rather than the regulator bump stops meaning that the glass can raise further as the seals soften over time and affect end stop learning.

Z-Axis height should only be adjusted by the 4mm Allen key adjusters as per ELSAPRO

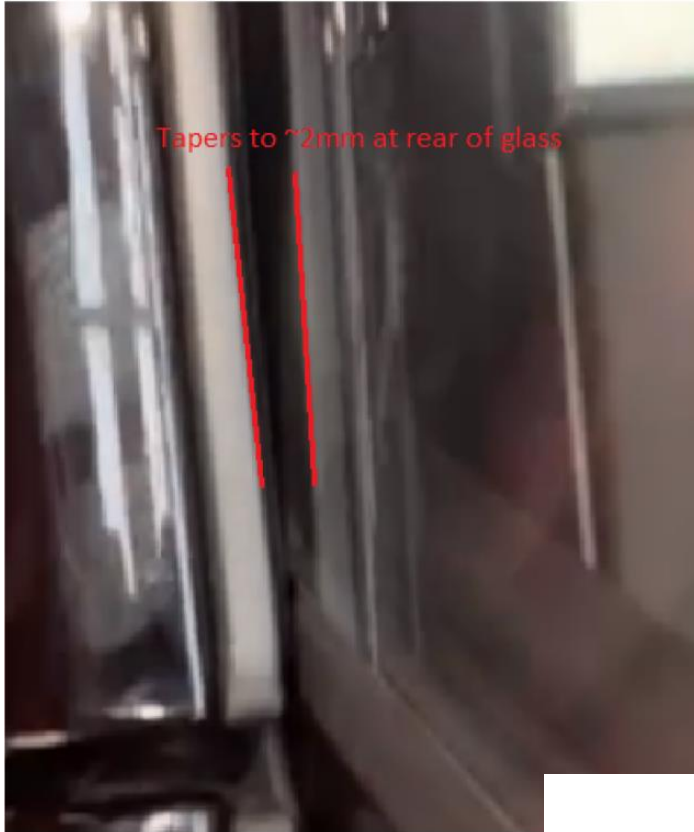
Images show a poor setting.
Circa 6mm at front edge (near wing mirror)
closing up to 2mm at the rear edge.

2mm at rear edge would have been set to achieve specified flush/2mm underflush profile condition between front and rear glasses, the rear quarter glass mirrors this taper condition. This potentially increases the risk of false anti trap as rear window/seal does not engage with front window at the correct angle. Suggested to set to specification on problem vehicles as per next slide. If both windows are set between 4-6mm then the flush/2mm underflush profile can be easily achieved.

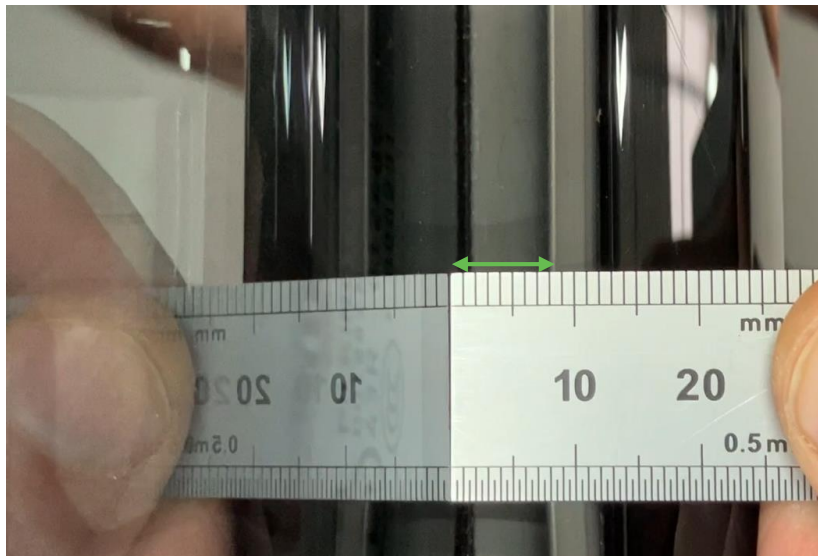
RHF window, front window closed, rear window open. Note gap

If more tension is required to resolve a wind noise or water ingress then aim for no more than 0.25mm of outboard movement.

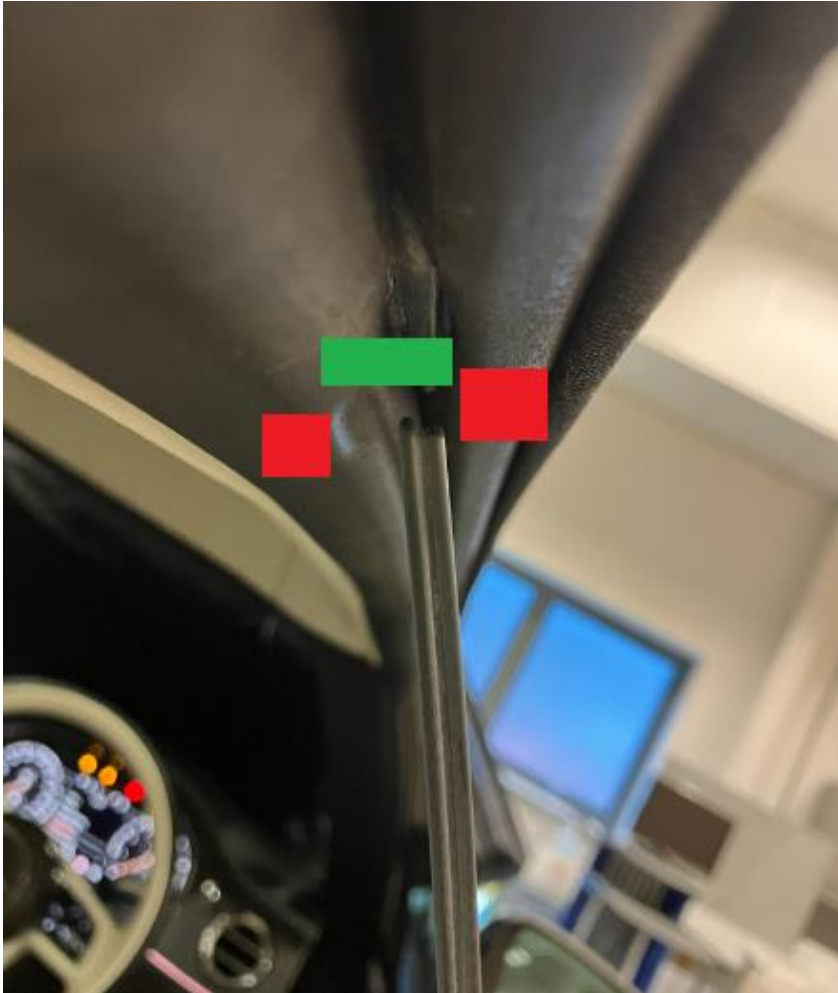
Windows should enter cant rail seal smoothly, making contact with inboard edge first and then be pushed outboard (green square).

Too far inboard increases the risk of the cant rail seal pinching, too far outboard will clash with cant rail brightware (red squares) For front door, poor door profile is a major contributing factor here and should be checked/adjusted if window found to be entering seal incorrectly
