Service Bulletin

Bulletin No.: 24-NA-047

Subject: Interior Indented Door Panel

Brand:	Model:	Model Year:		VIN:		Engine:	Transmission:
		from	to	from	to		
Cadillac	Escalade	2022	2024				
	Escalade ESV

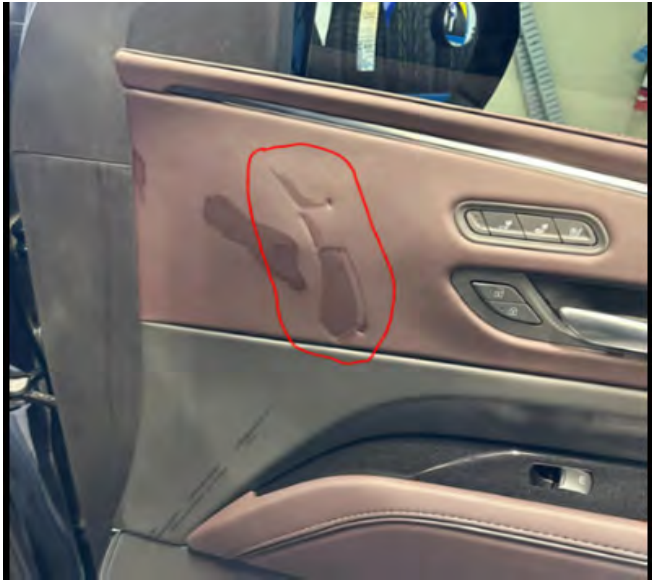
Involved Region or Country	North America, Europe, Kazakhstan, Russia, Middle East, Israel, Palestine, Japan, South Korea
Additional Options (RPOs)	
Condition	<p>Some customers may comment on one or both front interior door panels have become permanently indented at the forward/upper section of the door panel.</p>

<p style="text-align: right; font-size: small;">6570306</p>
Cause	The cause of the condition may be the edge material from the bezel/bolster has excessive contact pressure against the door panel retention clip when doors are closed.
Correction	<p>Replace the door panel and grind down the door panel retention clip.</p> <p>Important: Refer to the Electronic Parts Catalog (EPC) for the proper color door panel.</p>
