Technical Service Bulletin

GROUP CAMPAIGN	NUMBER 22-01-010G
DATE JANUARY, 2022	MODEL(S) G80 (RG3)

SUBJECT: MLM (MOOD LAMP MASTER) SYSTEM SOFTWARE UPDATE
(SERVICE CAMPAIGN T19G)

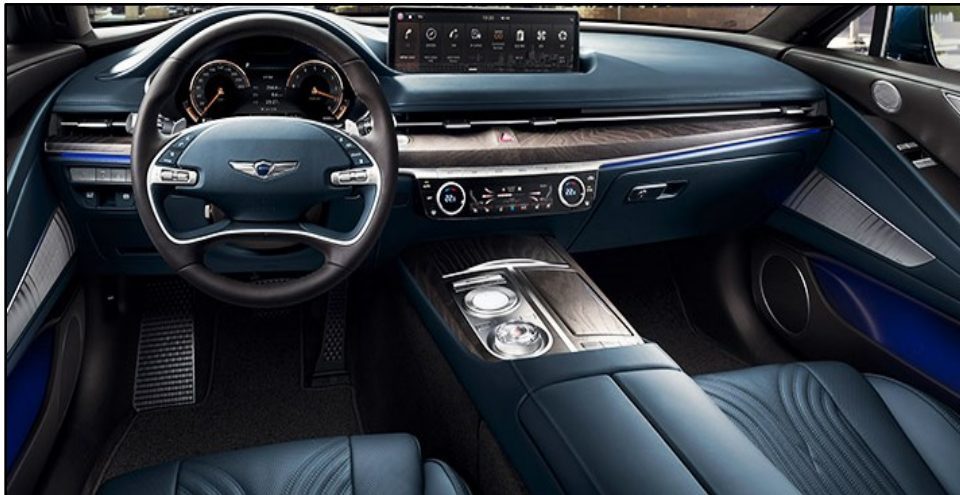
Description: Certain 2022MY Genesis G80 (RG3) vehicles may exhibit a condition where the interior mood/ambient lamp color cannot be changed.

This bulletin provides the service procedure to update the MLM (Mood Lamp Master) system software to resolve the condition stated above.
