<b>Technical Service Bulletin</b>	<b>GROUP</b> <b>BODY ELECTRICAL</b>	<b>NUMBER</b> <b>21-BE-008G</b>
	<b>DATE</b> <b>May, 2021</b>	<b>MODEL(S)</b> <b>G70 (IK)</b>
<b>SUBJECT:</b> SOFTWARE UPDATE FOR MODEM INFORMATION DISPLAYING ALL ZEROS

**Description:** Certain vehicles may experience 504 Time Out errors when using the Genesis Connected Services Mobile App. When asked to provide Modem Information (IMEI/USIM), the Head Unit (HU) displays all zeros. This bulletin describes the procedure to update the Head Unit Software to correct this condition.

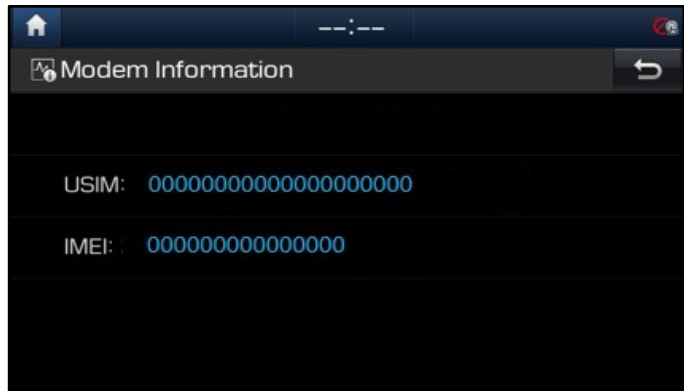
6. USIM & IMEI information will display all zeros.

You must attach a picture of the head unit displaying all zeros in order to submit the warranty claim. Claims submitted where the picture does not have the head unit displaying all zeros will be subject to charge back.

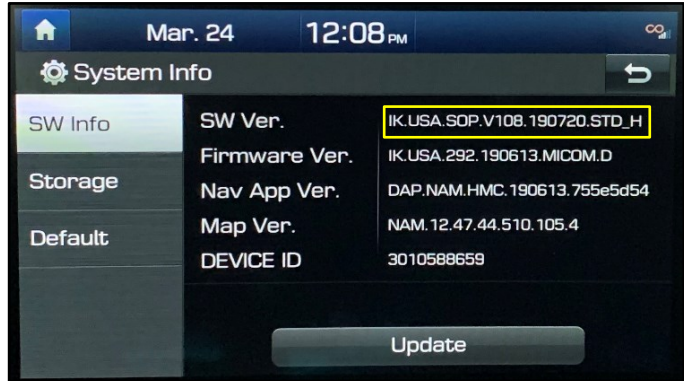
- 8. Confirm the current vehicle SW version is older than the update.

If the vehicle SW and update SW are the same – replace the Head Unit.
