Bulletin No.: PIT6101B

PIT6101B Intermittent No Audio

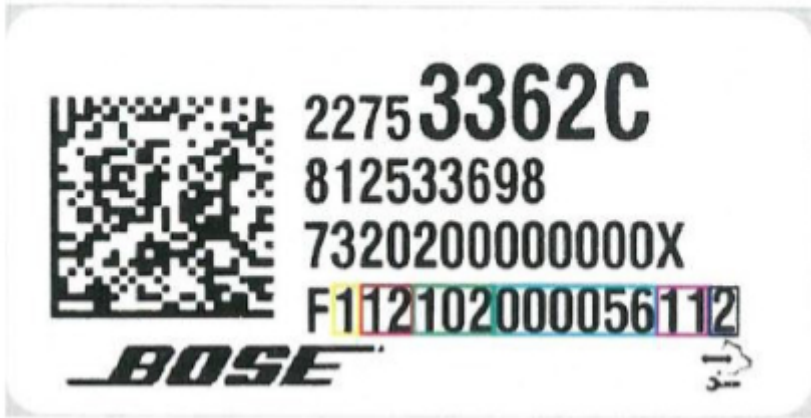
Retest and see if the concern is still present. For radio RPO IOK the latest software version is Y171. For radio RPO's IOS, IOU, and IOT V167 is the latest software version. 2. If the concern is still present, the concern may be in the amplifier. Replace the amplifier.

2. If the concern is still present, the concern may be in the amplifier. Replace and reprogram the amplifier. Please install an amplifier with a Julian date of 23327 and after. To read the Julian date, see the image below. If there is a stock of amplifiers with the Julian date before 23327, please ship the parts back to CCA.
