Preliminary Information

PIT6101D Intermittent No Audio

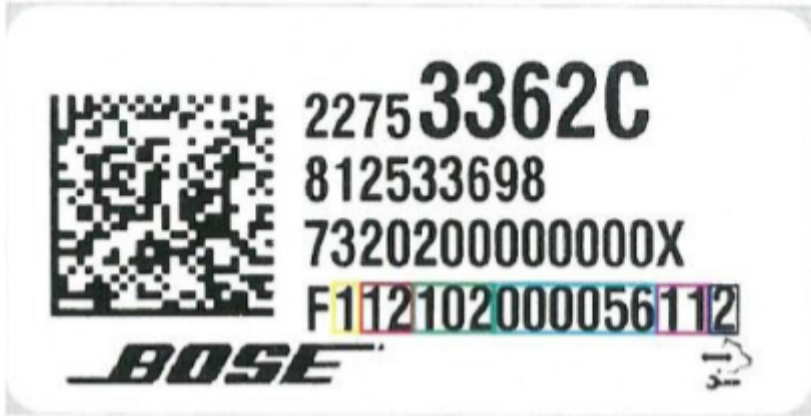
- If the concern is still present, the concern may be in the amplifier. Replace and reprogram the amplifier. Please install an amplifier with a Julian date of 23327 and after. To read the Julian date, see the image below. If there is a stock of amplifiers with the Julian date before 23327, please ship the parts back to CCA.

- Legend:
- Shift (1 for day shift, 2 for evening shift)
 - Year
 - Julian Date
 - Hour (24-hour format)
 - 6-digit serial number
 - Production Line
