Technical Bulletin

92 14 02 May 30, 2014 2037322

Washer Level Sensor

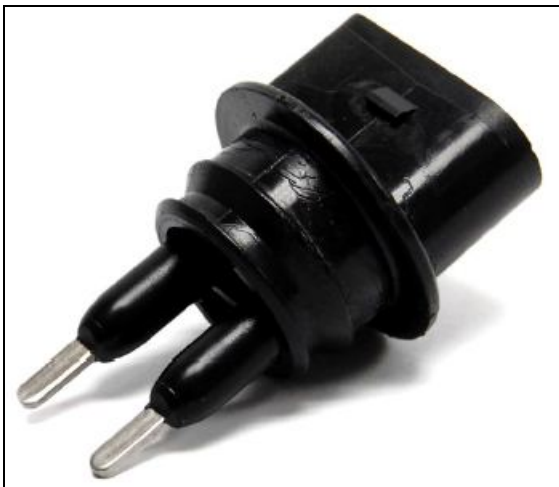
The issue is caused by the outside influence of non-approved formulated washer fluids. Non-approved washer fluids leave a clear film coating on the sensor probes, insulating the probes so they cannot read the fluid level.

Non-approved fluids can cause residues to form on the sensor which causes the washer fluid lamp to remain on when reservoir is full. A picture of the sensor in question (G33) and a picture of the approved cleaner (D-009-401-04) are provided below.

The indicator lamp in the instrument panel for washer fluid remains illuminated and the washer reservoir is full. Validate the washer reservoir is full with the proper washer solvent. Refer to Elsa for proper fluid type and fluid quantities under repair manual, maintenance, fluid capacity table. If the fluid is not blue in color, drain the fluid, remove the sensor and clean with cleaner (D-009-401-04) or equivalent. Reinstall the sensor, top off washer reservoir with proper fluid and validate that the indicator lamp in the instrument panel is no longer illuminated.
