# Technical Service Bulletin

## 87 HVAC blower setting adjustment not possible

87 24 71 2071139/3 April 5, 2024. Supersedes Technical Service Bulletin Group 87 number 23-54 dated August 25, 2023 for reasons listed below.

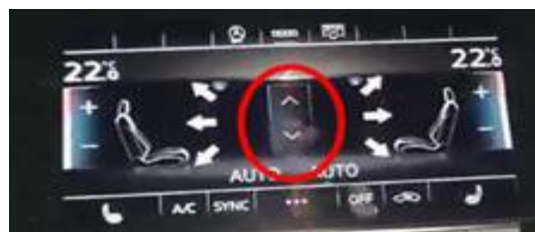
Figure 1. Normal HVAC control panel appearance.

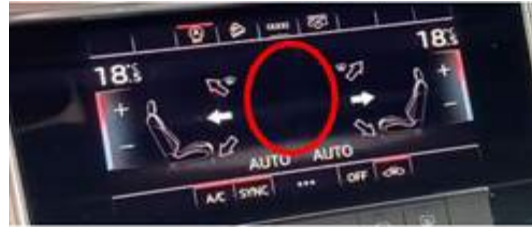
This symptom is difficult to reproduce. When the symptom occurs the center strip for the fan control is blank. The fan speed cannot be controlled.

**Figure 2.** Appearance of HVAC control with the fan speed strip blank.

The technical background regarding this intermittent symptom in the infotainment system is in analysis. A service solution is in discussion.

Please explain to the customer that, should this symptom occur, a restart of the MMI system will restore the fan control to the screen. Demonstrate to the customer the process by pressing and holding the on/off button for at least 10 seconds. The restart should take less than a minute.

Do not replace any parts should the vehicle exhibit this symptom. Parts replacement will not solve this issue. Any parts replaced for this condition under warranty will be debited.
