| GEN | 2023-2024MY Forte (BDm) |

TECHNICAL SERVICE BULLETIN

SERVICE ACTION: TIRE MOBILITY KIT

INSPECTION & REPLACEMENT/REPAIR (SA556)

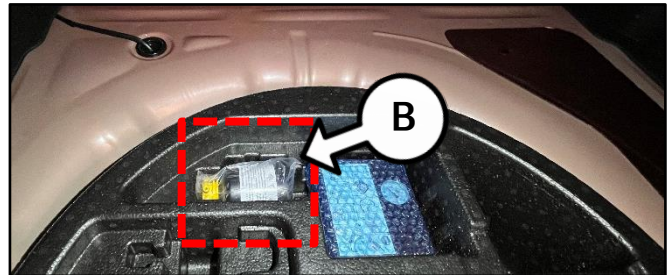
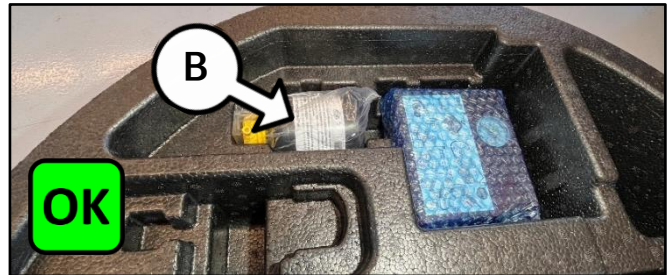
- If sealant has **not** leaked from the TMK sealant can (B) (OK), proceed to step 4.

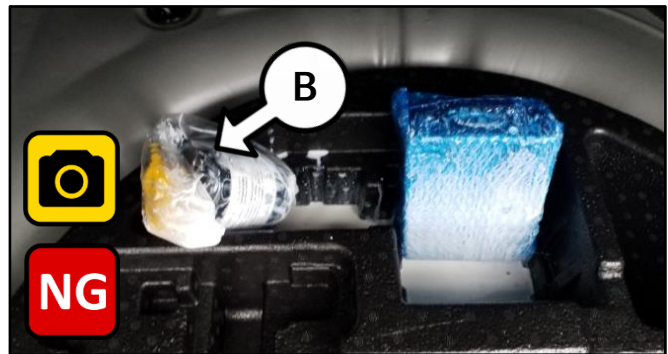
- If sealant **has** leaked from the TMK sealant can (B), take one (1) clear KVID photo and proceed to 'Repair Procedure' step 5.

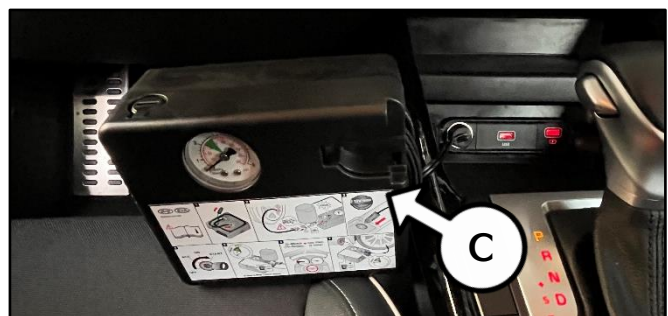
If leaked sealant has penetrated the inflator bag, test the inflator (C) for proper operation. If inflator and/or other damaged parts require replacement due to leaked sealant, follow normal warranty procedures and attach a KVID photo of the damaged component to the warranty claim.

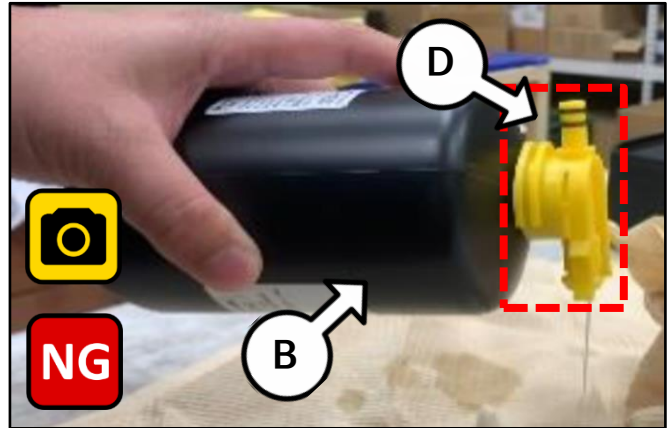
4. Remove sealant can (B) from the bag and position horizontally so the spout is facing downward.
 - If sealant has **not** leaked from the sealant can cap (D) **(OK)**, proceed to the 'Repair Procedure'.
 - If sealant has leaked from the sealant can cap (D) **(NG)**, replace the sealant can (B), **take one (1) clear KVID photo** and proceed to 'Repair Procedure' step 5.
