**Diagnostic Sheet**

# MC20 Cielo – Interference of the liftgate door while opening

DATE: March 4, 2024

**Models:** MC20 Cielo (M240) All MY

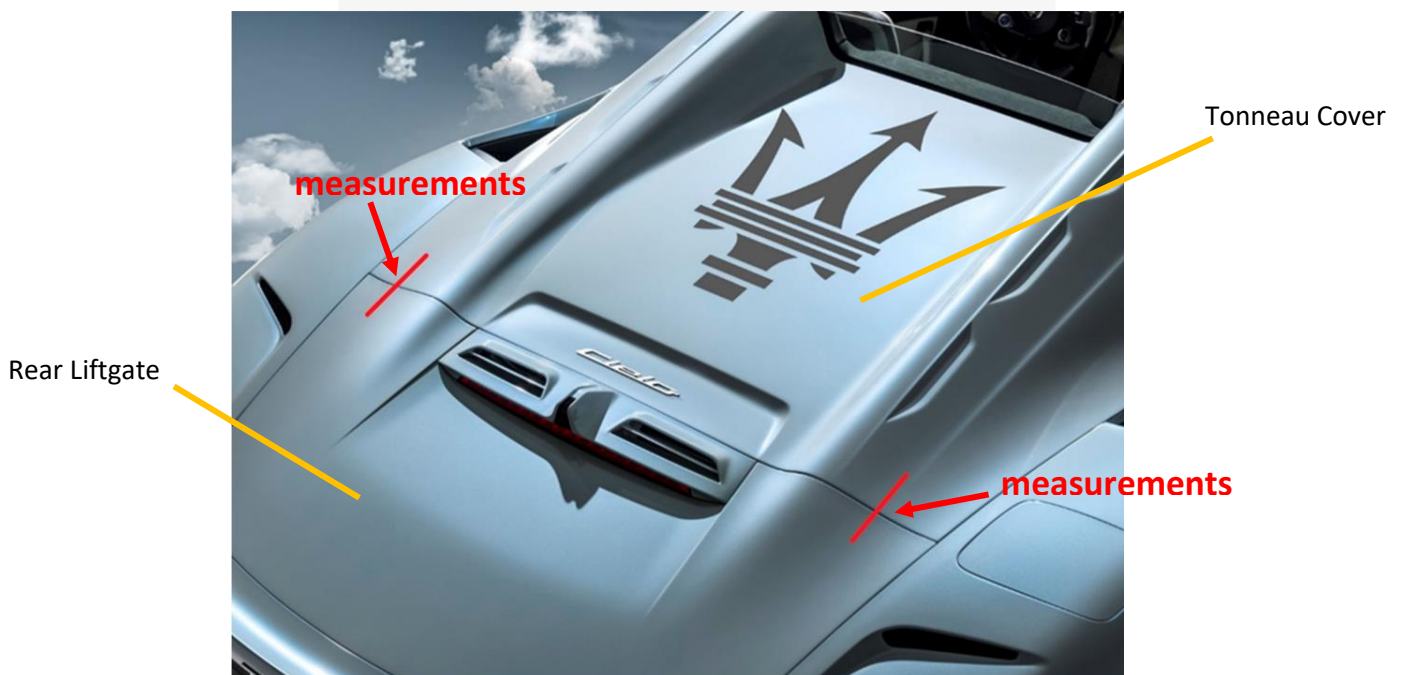
2. Perform two gap and profile measurements between the liftgate door and tonneau cover at the points highlighted in the image below with the red lines.

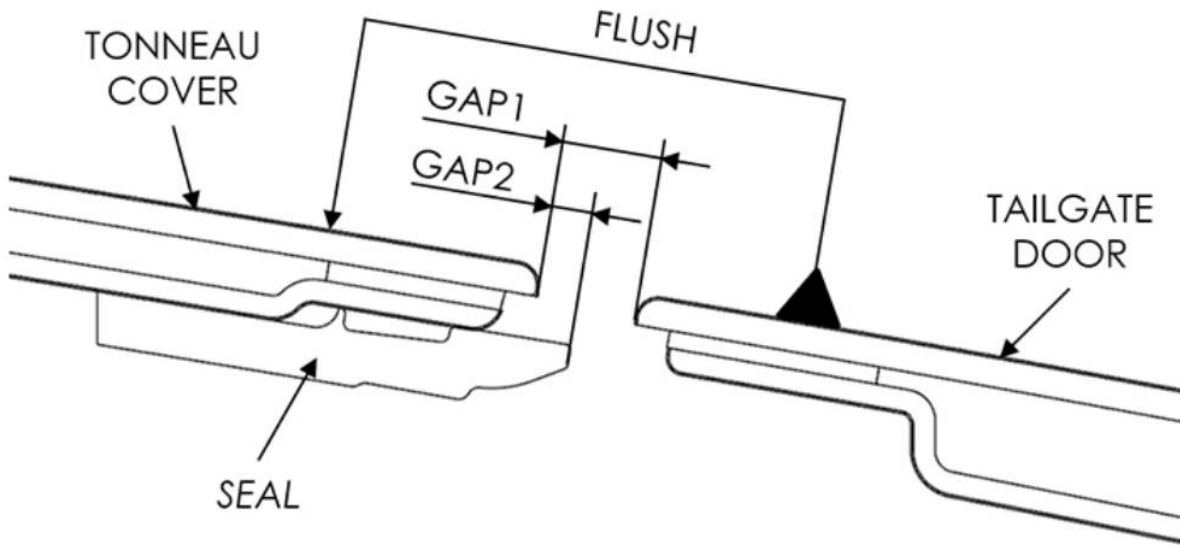
The gap specification "GAP1" is 8,5 0/+0,5 mm The tonneau cover profile specification "FLUSH" compared to the tailgate door is 1 ±1 mm
