GENERAL MOTORS
DCS6857
URGENT - DISTRIBUTE IMMEDIATELY

Subject: N232427050 - Customer Satisfaction Program
Transmission Fasteners Improperly Torqued

Models: 2023-2024 Chevrolet Corvette

N232427050 Transmission Fasteners Improperly Torqued

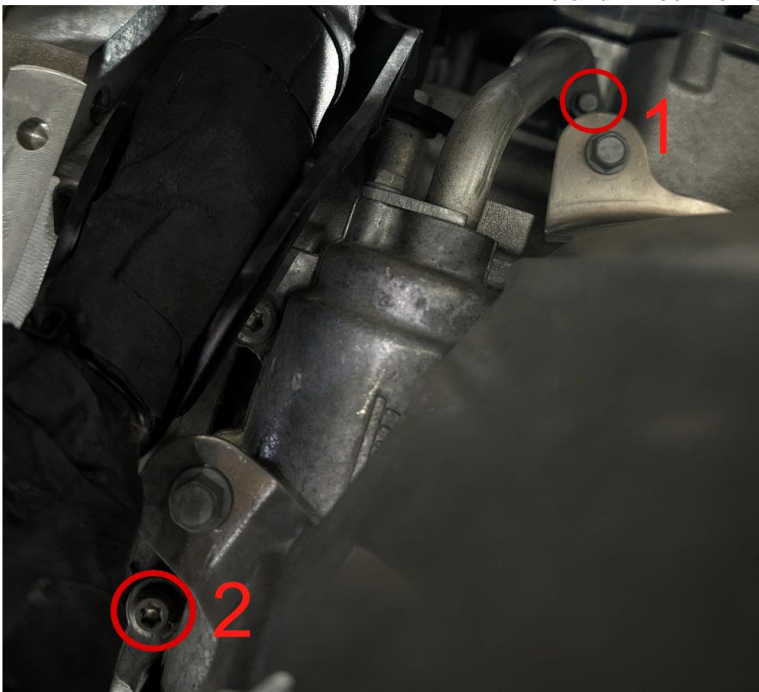
6576543

Condition	Certain 2023-2024 model year Chevrolet Corvette vehicles, may have a condition in which the transmission fasteners were improperly torqued.
Correction	Dealers will retorque the transmission fasteners.

2. Going through the center of the rear wheel liner, torque the circled bolts to the specifications below.
 - For (1), torque the bolt to 6.5 N-m (58 lb in)
 - For (2), first loosen the bolt. Then, retorque the bolt to 4.1N-m (36 lb-in) on the first pass, followed by 100 degrees on the final pass.
3. Reinstall the driver's side rear wheel. Refer to *Tire and Wheel Removal and Installation* in SI
