48-23-01 - Travel Assist Currently Not Available

Release date: 4/16/2024

Technical Background

Hardware-related deviation of the sensor mat (“hands on detection”) in the steering wheel and software-related deviation in the steering wheel touch detection control module -**J1158**-.

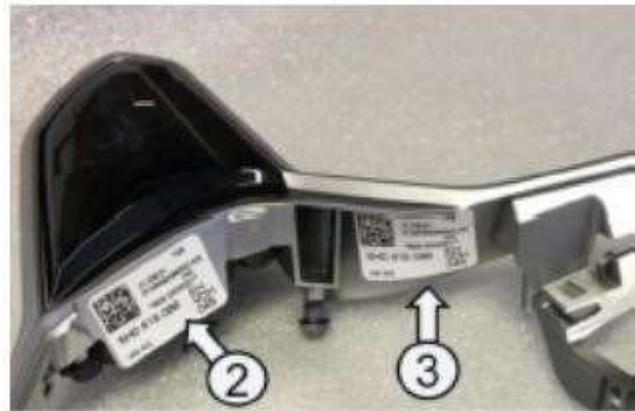
Figure 2.

Position of old (2) new (3) label on trim panel.

The old label (see Figure 2) must not be covered up.
