Service Bulletin

Bulletin No.: 24-NA-067

Subject: Headlamp Aim Is Uneven

Brand:	Model:	Model Year:		VIN:		Engine:	Transmission:
		from	to	from	to		
Cadillac	XT4	2024	2024	-	-	All	All

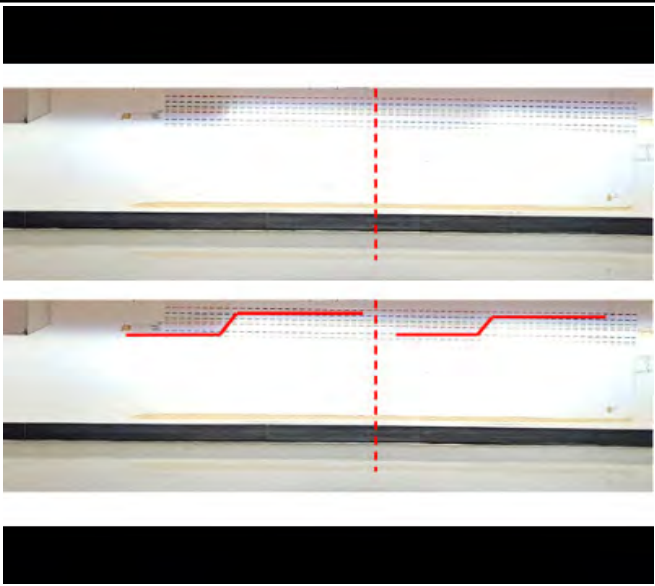
<p style="text-align: right; font-size: small;">6600469</p>
Cause	The notch pattern is normal and by design.
Correction	DO NOT replace the headlamps or adjust headlamp aim for this condition. This is a normal function of the lamps.

Please communicate to the customer that the headlamp system is functioning as designed and this is a normal condition of their vehicle. Please share this information with the customer, including a copy of this message.
