Service Bulletin

Bulletin No.: PI0657A

Subject: Deformed or Dimpled Liftgate Center Applique, Liftgate Paint Damage Evident at Lower Outer Edge of Applique

Models: 2007-2013 Chevrolet Suburban, Tahoe
2007-2013 GMC Yukon Models, Yukon XL Models

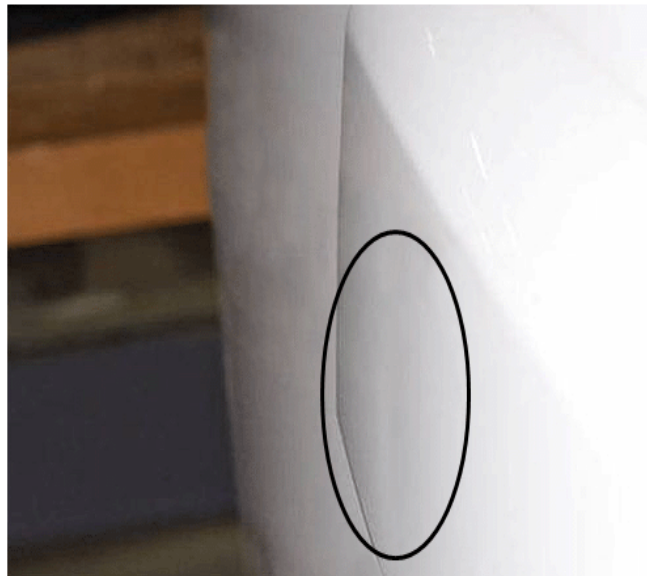
2748946

Some customers may comment on seeing a dimpling or deformation (shown circled above) near an outer edge of the liftgate center applique.

The design of the applique might allow deformation or dimpling of the applique surface if the retaining nuts are overtightened. In some cases, damage to the applique mounting bosses may be evident if the studs were overtightened.

The liftgate center applique design has been revised to be more resistant to overtightening, provide enhanced anti-rotation measures for the mounting studs and also provide an improved interface to lessen contact with the liftgate.

Note: The updated applique design went into production for the 2012 model year. The applique should **Not** require replacement on a 2012 or newer vehicle, unless Condition 1 is present.

For 2011 or earlier vehicles, replace the liftgate center applique with the appropriate new service part listed in the table below. Refer to Liftgate Center Applique Replacement in SI.

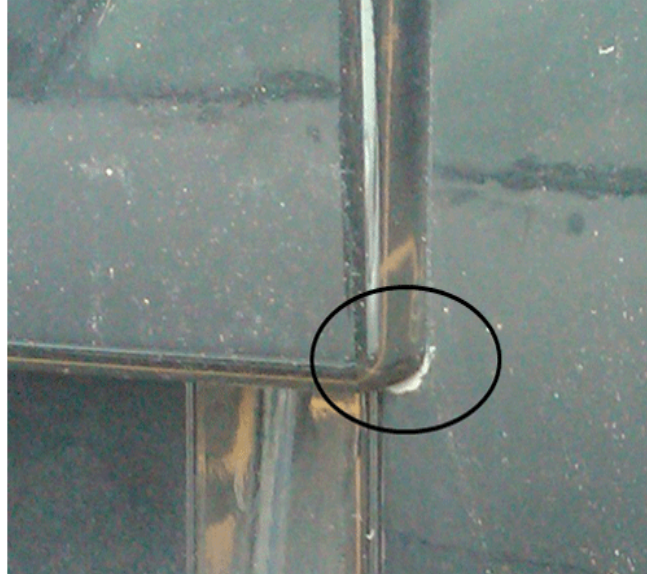
2748947

Some customers may comment on paint damage (shown circled above) on the liftgate at the lower outboard edges of the center applique.

The design of the applique in conjunction with the forming of the license plate pocket in the liftgate may allow the lower outboard edges of the applique to have contact with the liftgate.
