Bulletin No.: PI0695A

PRELIMINARY INFORMATION

Subject: Diagnosis and Repair HVAC Blower Function

Models: 2008-2013 Cadillac Escalade Models

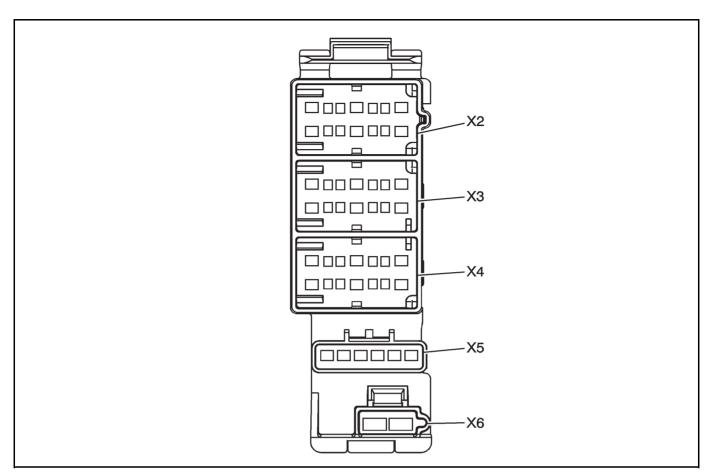
1991088

One possible cause of this condition may be the contacts in the HVAC junction block(s) located at the right side of the instrument panel.

- 2. Identify Junction Block X4 and X6.
- 3. With the ignition key in the on position, turn on the HVAC blower and apply light hand pressure to the connectors. Determine if this movement affects the blower operation (intermittent operation).
- 4. Determine which junction block is affecting the blower operation.
