Service Bulletin

Bulletin No.: PI0746B

Subject: Malfunction Indicator Lamp (MIL) On, Poor Acceleration, Throttle Body Freezing, Multiple DTCs Set, Ice Deposits and/or Oil Deposits Present in Air Inlet Duct

Models: 2008-2011 Buick Enclave
2007-2011 Chevrolet Malibu
2009-2011 Chevrolet Traverse
2007-2011 GMC Acadia
2007-2010 Pontiac G6
2007-2010 Saturn OUTLOOK
Equipped with 3.6L Engine (RPOs LY7, LLT)

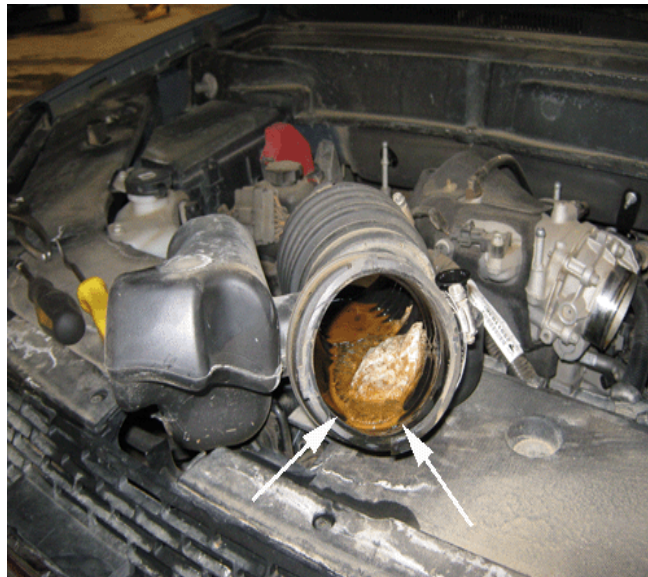
2837688

Technicians may find the presence of DTCs P0101, P0171, P0172, P0174, P0175, P1516, P2177, P2178, P2179, P2180, P2187, P2188, P2189, and/or P2190 along with either ice or oil deposits in the air inlet duct.

Ice formation is caused by condensation freezing at the base of the throttle body with additional collection of ice formation deposits in the air inlet duct. Freezing condensation forms after the vehicle has been driven and then parked in low ambient temperatures.

Oil deposits are the collection of the engine vapors, fuel dilution and oil mist at the base of the throttle body with additional formation collecting in the duct.

1. Remove both camshaft covers for servicing of the PCV system. Refer to Camshaft Cover Replacement Left and Right Side in SI.
2. Clean the PCV orifice with low VOC brake cleaner. Allow to air dry with compressed shop air.
3. Replace the bank1 camshaft cover gasket.
4. Reassemble the bank1 camshaft cover.

Tighten the camshaft cover bolts to 10 N•m (89 lb in).

5. Replace the bank2 camshaft cover and replace the camshaft cover gasket.
6. Reassemble the bank2 camshaft cover.

7. Install the insulated PCV tube.
