# Service Bulletin

Bulletin No.: PI0746D

**Subject:** Malfunction Indicator Lamp (MIL) On, Poor Acceleration, Throttle Body Freezing, Multiple DTCs Set, Ice Deposits and/or Oil Deposits Present in Air Inlet Duct

**Models:** 2008-2011 Buick Enclave  
2007-2011 Chevrolet Malibu  
2009-2011 Chevrolet Traverse  
2007-2011 GMC Acadia  
2007-2010 Pontiac G6  
2007-2009 Saturn AURA  
2007-2010 Saturn OUTLOOK  
Equipped with 3.6L Engine (RPOs LY7, LLT)

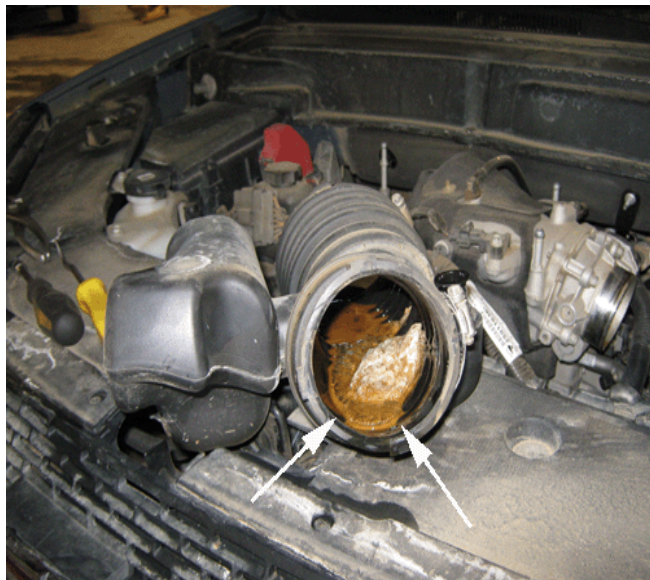
2837688

Technicians may find DTCs P0101, P0171, P0172, P0174, P0175, P1516, P2177, P2178, P2179, P2180, P2187, P2188, P2189 and/or P2190 along with either ice or oil deposits in the air inlet duct.

Ice formation is caused by condensation freezing at the base of the throttle body with additional collection of ice formation deposits in the air inlet duct. Freezing condensation forms after the vehicle has been driven and then parked in low ambient temperatures.

Oil deposits are the collection of the engine vapors, fuel dilution and oil mist at the base of the throttle body with additional formation collecting in the duct.
