<small>Technical Journal Title</small> Noise Reducing Encapsulation Cover For XC60 Long Range PHEV ERAD		<small>Ref. No.</small> TJ 36841.1.1	
<small>Issuer (Dept.)</small> Technical Service		<small>Issue Date</small> 3/27/24	<small>Status Date</small> 4/16/24
<small>Car Market</small> United States and Canada	<small>Partner</small> 3 US 7510 Volvo Car USA	<small>Function Group</small> 4632	
<small>Function Description</small> Electrical rear axis drive		<small>Page</small> Page 1 of 6

TJ Instruction VCC-528081-2

Title	Electric rear axle drive ERAD	Page	1 (4)
Action	Product fix	Operation number:	98296-2

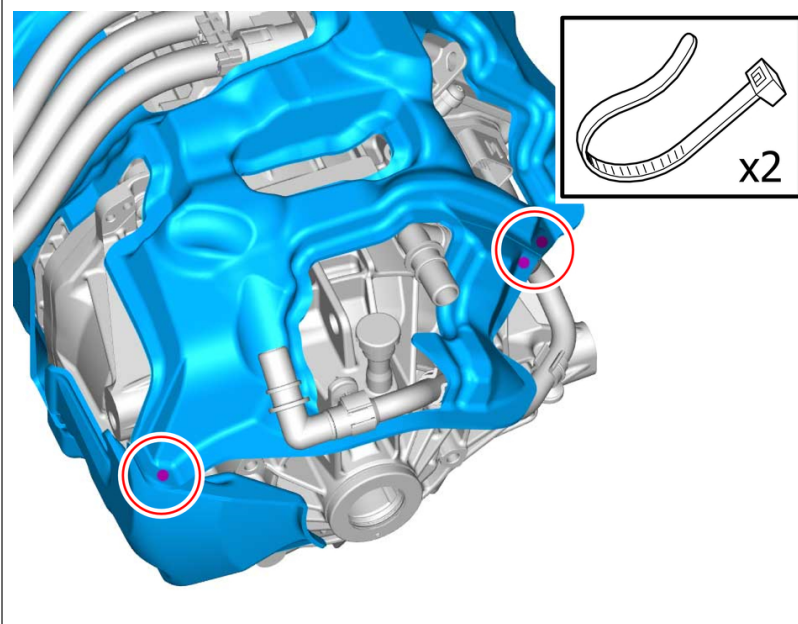
Caution! Make sure the component is fitted as illustrated.

Use a cable tie

An ERAD Encapsulation Cover is now available to decrease the sound level by up to 3dBA.

- **Order Part number 32324792 and follow the attached instructions.**
- **Note: This solution is only valid for XC60 vehicles.**

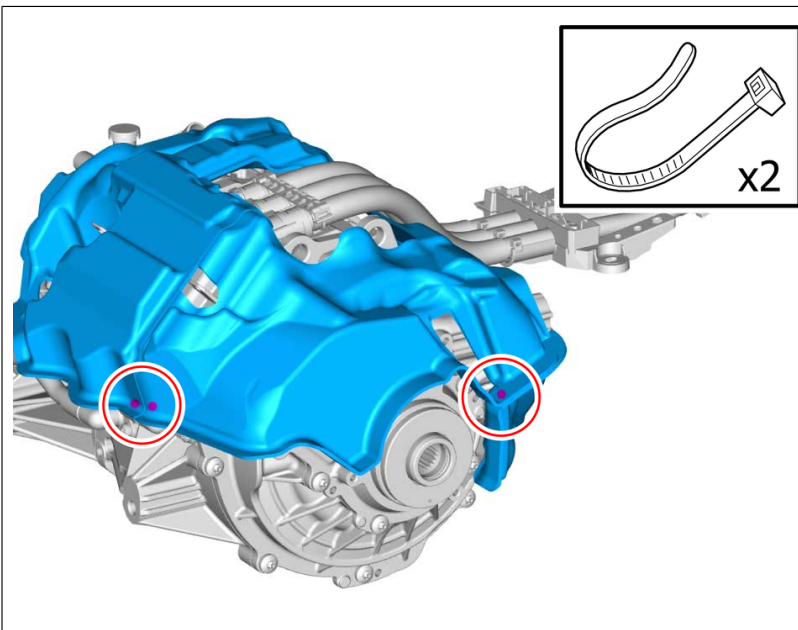
Caution! Make sure the component is fitted as illustrated.

Use a cable tie

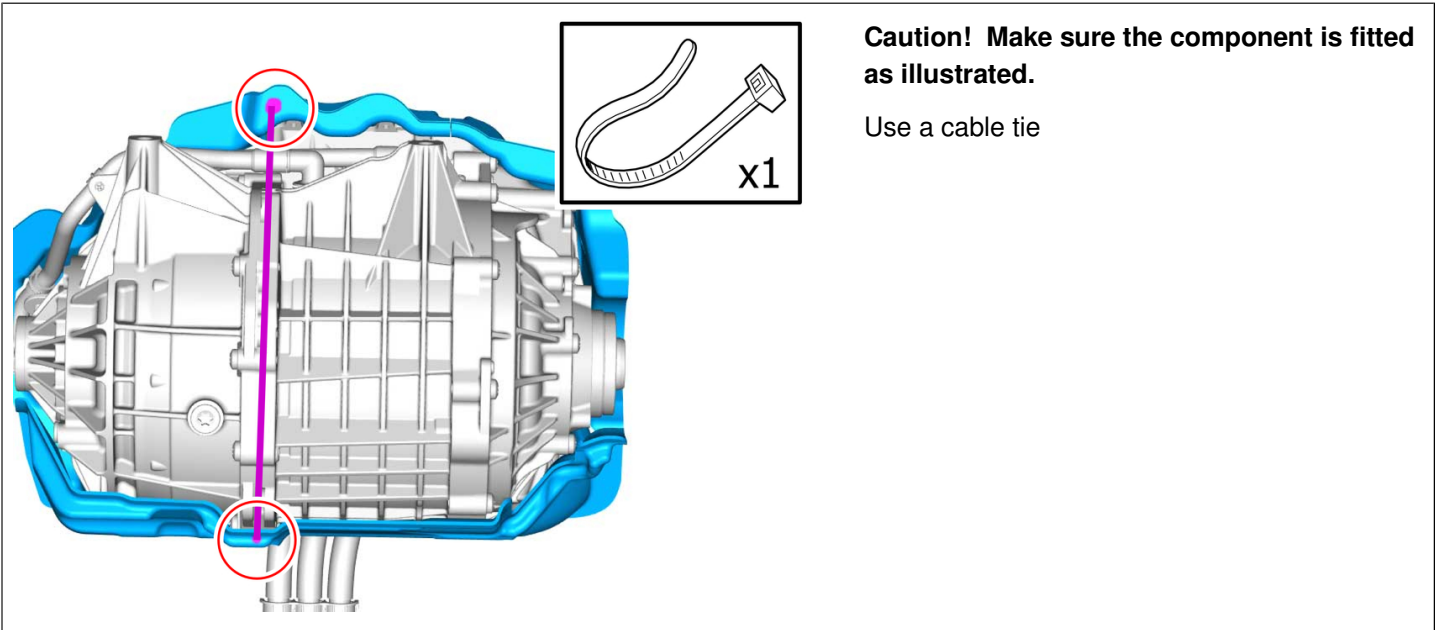
Caution! Make sure the component is fitted as illustrated.

Use a cable tie
