# Service Bulletin

#### Subject: Clunking Noise from Rear of Vehicle (Re-torque Leaf Spring Bolts)

Brand:	Model:	Model Year:		VIN:		Engine	Transmission:
		from	to	from	to	Engine:	fransinission.
Chevrolet	Silverado 2500HD/ 3500HD	2020	2024			All	All
GMC	Sierra 2500HD/ 3500HD	2020	2024			All	All

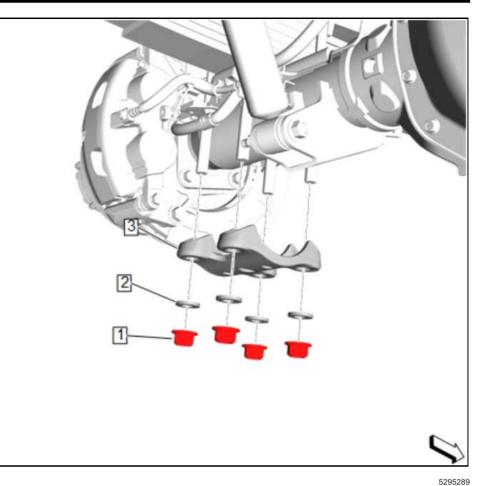
Involved Region or Country	North America, Middle East		
Condition	Some customers may comment about a clunking noise coming from the rear of the vehicle. Upon further investigation, the technician may diagnose the noise coming from the rear suspension leaf spring area.		
Cause	This condition may be caused by movement between the anchor plate and axle assembly.		
<b>Correction</b> The noise may be resolved by re-torqueing the joints of the leaf spring asse

- 2. Loosen the leaf spring U-bolts (1).
- 3. Re-torque the leaf spring U-bolts (1). Refer to SI for torque specifications.
- 4. Repeat steps 2 and 3 for the right side leaf spring.
- 5. Re-test the vehicle for the same clunking noise. If the issue remains, continue diagnosis referring to SI.
