Surround View Camera Intermittent Operation

Vehicles Affected

Models	Model Year	Model Type	VIN Range	Vehicle-Specific Equipment
911	As of 2020 up to 2023	992	N/A	KA6

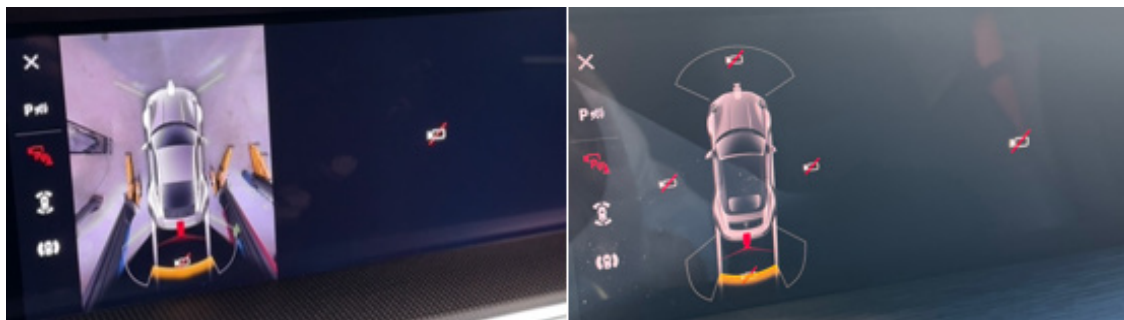
Figure 1

Customer complains of intermittent operation for one or multiple surround view cameras. Failed surround camera(s) appear blank with a crossed-out camera icon.
