# Technical Service Bulletin

## 27 48V vehicle electrical system warning, DTC U046900 stored in the ECM

27 24 72 2058831/14 April 26, 2024. Supersedes Technical Service Bulletin Group 27 number 24-69 dated March 12, 2024 for reasons listed below.

Model(s)	Year	VIN Range	Vehicle-Specific Equipment
A6, A7, A8, and Q8	2019 - 2023	All	48V electrical system
A6 allroad, S8, and Q7	2020 - 2023

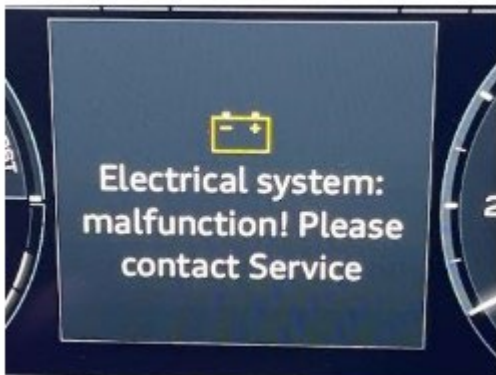
- The message “Electrical system: malfunction! Please contact Service” is displayed on the instrument cluster (Figure 1).
- A yellow or red battery warning symbol is displayed on the instrument cluster.

**Figure 1.** Cluster Warning Message.

- **DTC U046900:** Invalid data received from starter/generator control module (symptom 36564).

A hardware related issue may cause the belt starter generator (BSG) to stop working as intended.

If the following event memory entry is shown in ODIS, replace the starter-alternator according to ELSA and reevaluate the concern:
