**WRC5 - Checking Main Wire Harness in Luggage Compartment and Rework if Necessary (Stop Delivery)**

Model Year: **As of 2024 up to 2025**

Vehicle Type: **Panamera (YAA / YAB)**

Concerns: **Main wire harness in luggage compartment**

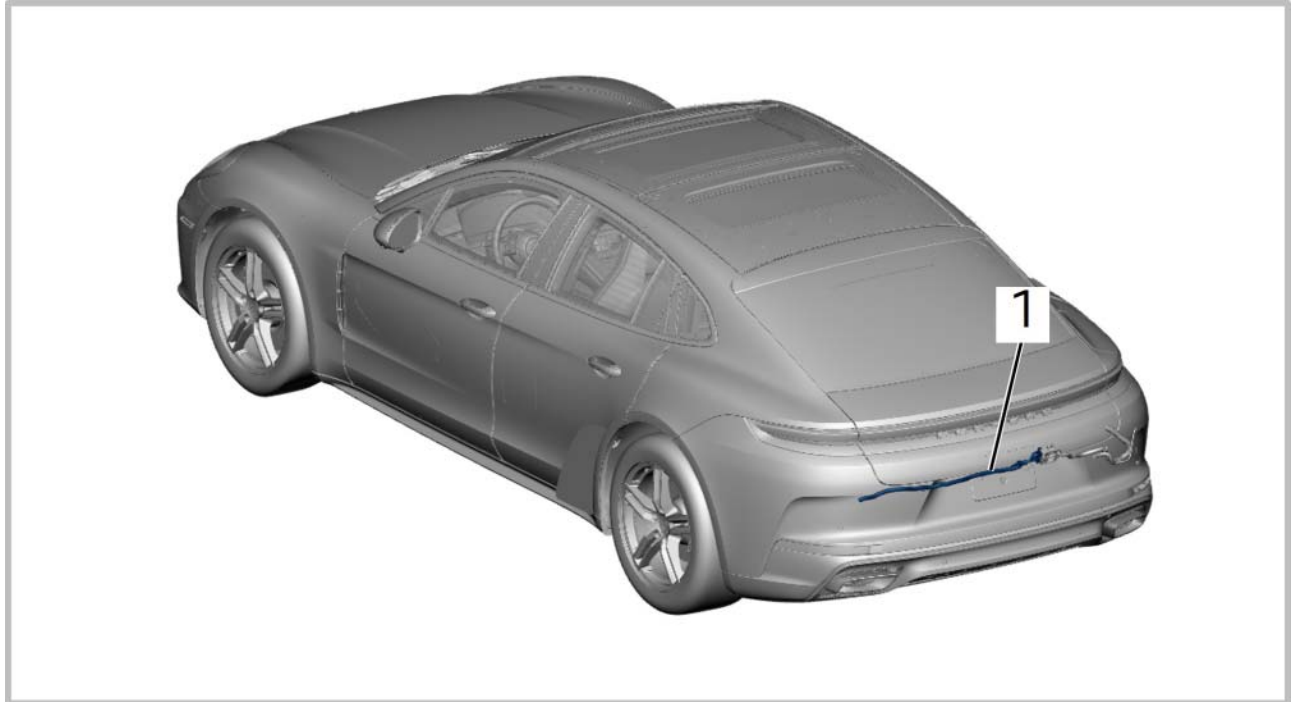
*Installation position of main wire harness in luggage compartment*

Cause: **There is a possibility that, due to a process error during assembly, the main wire harness in the luggage compartment was not routed according to specifications in the affected vehicles.**

If this is the case, damage to the main wire harness cannot be ruled out.

1 – Main wire harness in luggage compartment (**check and rework if necessary**)

Action: Before delivery, check the main wire harness in the luggage compartment and rework if necessary.

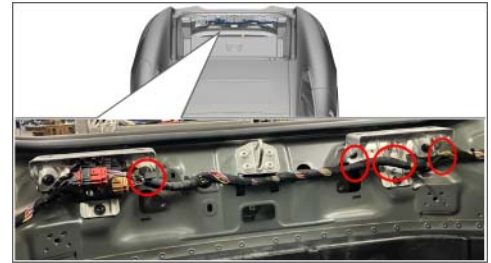
- 2.1 Deburr the sharp sheet metal edges at the marked points using emery paper.
- 2.2 Then check the cables for damage at marked points ⇒ *Checking main wire harness in luggage compartment* in the area of the sheet metal edges.

- If no, or only slight, traces of chafing are visible on the wire harness, wrap the wire harness 2x at the marked points with fabric adhesive tape ⇒ *Wrapping main wire harness in luggage compartment*. Then complete the vehicle again. Continue with Step 4.
- If the lines are only cut open at their insulation, but not the strands themselves, the damaged insulation must first be repaired using suitable cable repair accessories and then wrapped 2x around the wire harness with fabric adhesive tape ⇒ *Wrapping main wire harness in luggage compartment*. Then complete the vehicle again. Continue with Step 4.

- If the strands are damaged, the line must be repaired. Continue with Step 3.

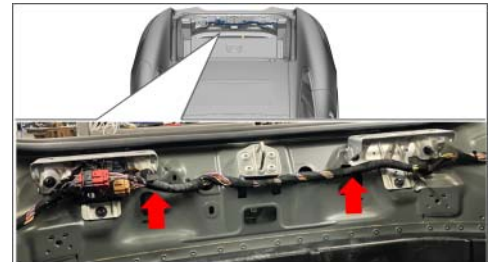
Due to the increase in the cross-section at this point, the luggage compartment trim panel may squeeze the wire harness. In this case, disconnect the line at a different location and reroute it up to the plug. These additional activities can be invoiced using a reimbursement claim for the original campaign claim. Document graphically and/or attach corresponding damage in the PQIS line.

Make sure that the line is not repaired at tight points ⇒ *Constriction for main wire harness* -**Arrows**- with a crimp connection.
