WPQ1 - Checking Top Door Hinges (Body Side) and Reworking if Necessary (Workshop Campaign)

Model Line: **911 (992)**

Model Year: **2023**

Concerns: **Top door hinge (on body side)**

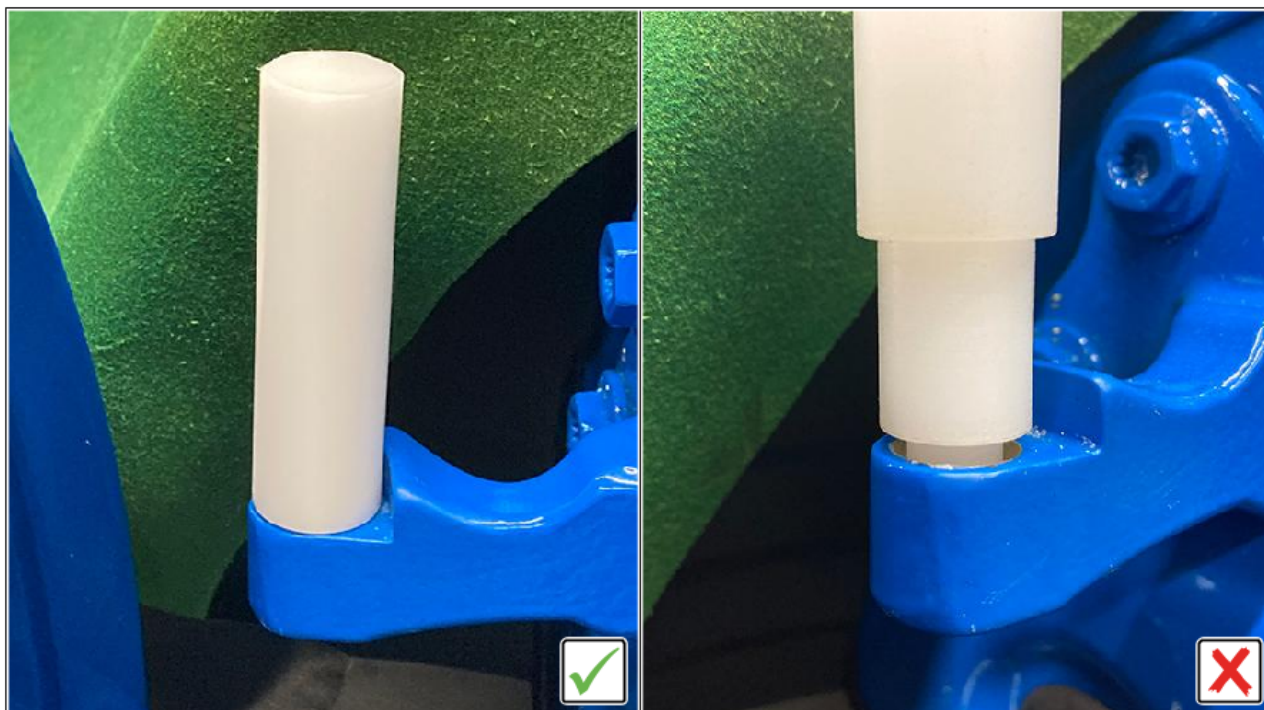
Checking top door hinges (on body side)

- Work Procedure: 1 Insert the test pin into the bore of the door hinge (on body side) at the top.
- 2 Visually inspect the area between the test pin and the door hinge collar (on body side) at the top for the air gap.

Assessment		Action
(✓)	No air gap can be detected between the test pin and the door hinge (body side) collar at the top right and left side.	Continue with Step 3. [Scope 1 or 2]
(✗)	An air gap can be detected between the test pin and the door hinge (body side) collar at the top of one or both sides of the vehicle.	Continue with ⇒ <i>Technical Information 'Reworking door hinges (body side)'</i> One hinge: [Scope 3 or 4] Two hinges: [Scope 5 or 6]

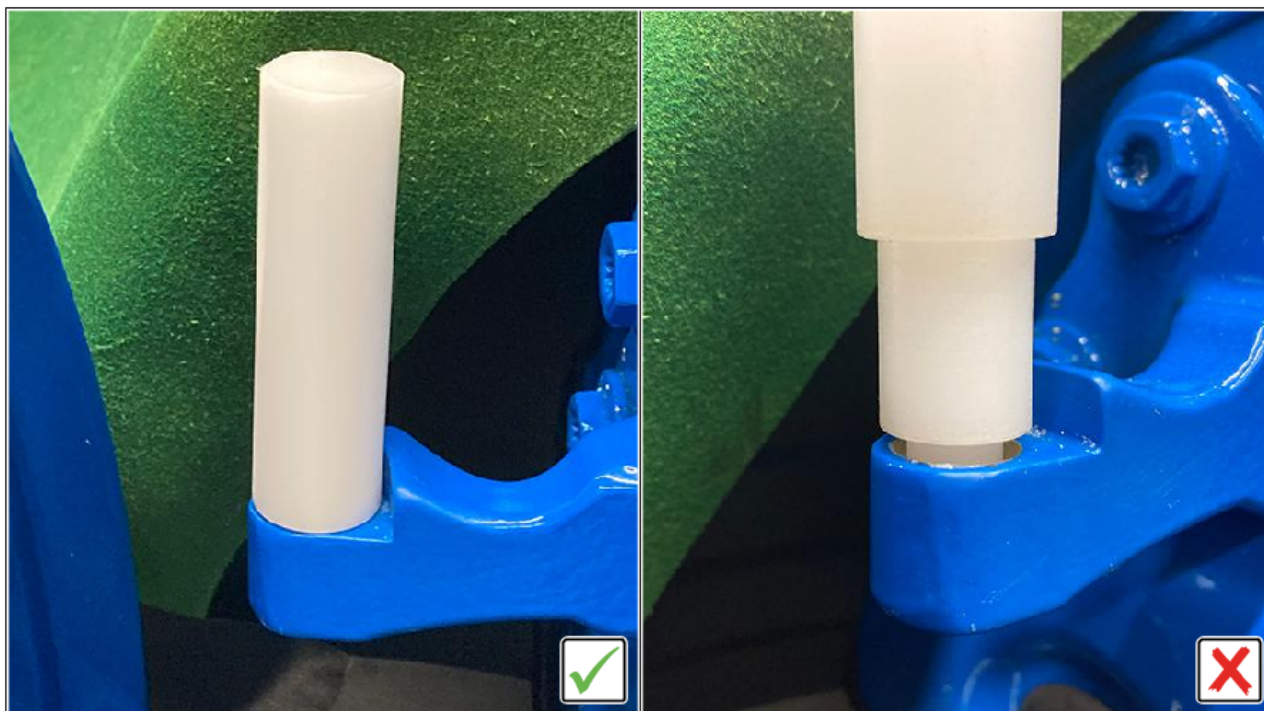
Checking top door hinges (on body side)

- 2 Visually inspect area between test pin ⇒ *Checking top door hinges (on body side)-1-* and the door hinge collar (on body side) at top ⇒ *Checking top door hinges (on body side)-2-* for air gap ⇒ *Checking top door hinges (on body side)-Arrows-* again.

Assessment		Action
(✓)	No air gap can be detected between the test pin and the door hinge (body side) collar at the top right and/or left side.	Continue with Step 2.
(x)	An air gap can be detected yet between the test pin and the door hinge (body side) collar at the top right and/or left side.	Repeat step 1.
