SERVICE BULLETIN

APPLICABILITY: 2019MY Legacy & Outback **NUMBER:** 15-318-24R
 2019-21MY WRX/STI **DATE:** 02/23/24

SUBJECT: Data Communication Module (DCM) Bypass Box **REVISED:** 04/17/24

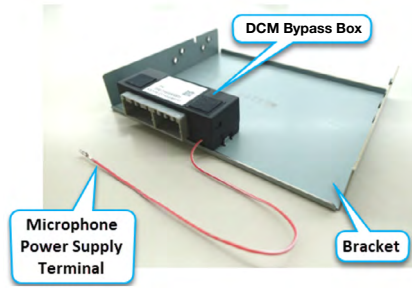
Part Description	Part Number
DCM BYPASS BOX	86229AL400
