**SERVICE BULLETIN**

**APPLICABILITY:** 2020-2022MY Outback & Legacy  
 2022-2023MY BRZ  
 2022-2023MY WRX

**NUMBER:** 15-270-20R

**SUBJECT:** FOTA (Firmware Over-The-Air) Reprogramming for DENSO Gen 4 Audio / Navigation Infotainment Systems

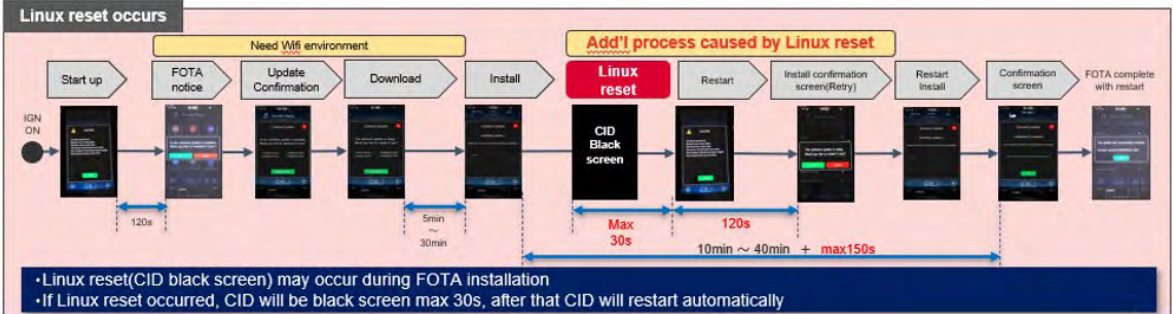
<p>However, in rare case, the CCU restarts itself* during installation.</p>

<p><b>Note*)</b> Even if this symptom occurs, after approximately 2 minutes, the system resumes, and the CID comes back to the below screen. Customer can then push the “Install Now” to proceed with the installation.</p>
