# Technical Service Bulletin

## 87 Air conditioning inoperative; DTC 00457, 00256, 01592

87 24 74 2020124/14 April 29, 2024. Supersedes Technical Service Bulletin Group 87 number 15-69 dated August 24, 2015 for reasons listed below.

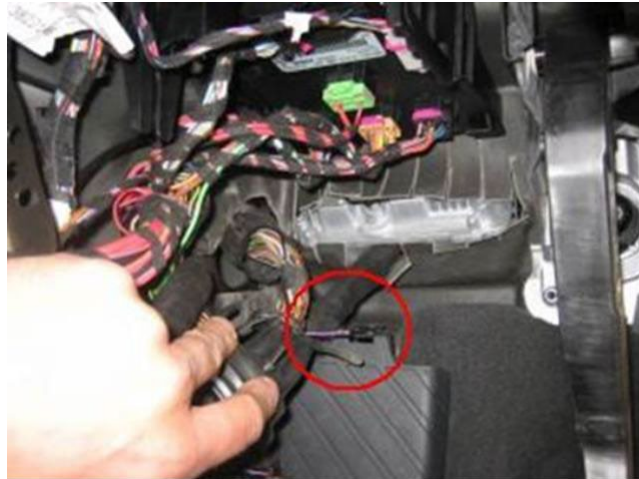
There are two known sections in the wiring harness that can be affected, but the potentially affected areas are not limited to these two known sections. One of the known sections is in the driver's footwell area where the wire harness enters the interior of the car from the engine bay (Figure 1).

*Figure 1. Wire harness in driver footwell area.*

6. If a cut wire is found, install an overlay wire for the LIN bus signal. Do *not* attempt to repair the existing wire harness.

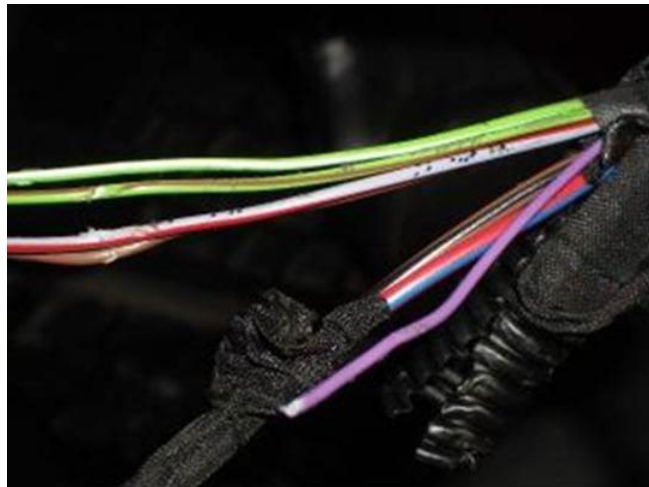
The second known section is in the wire harness located under the driver's side headlight (Figure 2).

*Figure 2. Wire harness under driver's side headlight.*

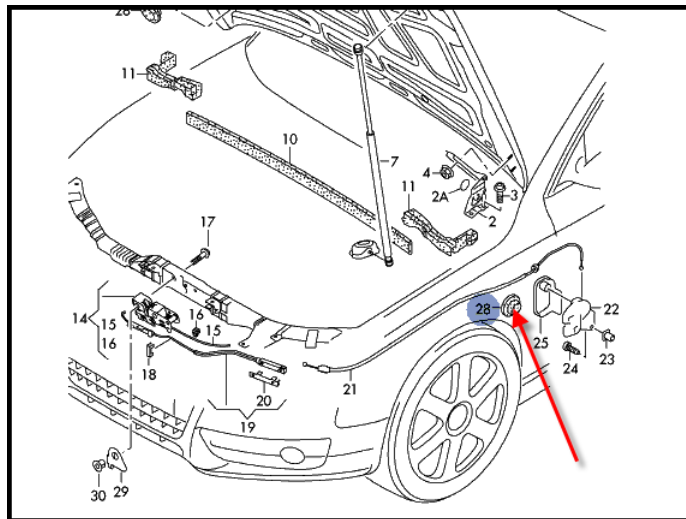
**Figure 3.** Grommet in driver's side fender/lower A-pillar area used for pass-through for new overlay wire.

- a. Route the new LIN bus wire from the vehicle electrical system control module, J519, to the sender for sensor G395 so that it enters the interior of the vehicle through the driver's side fender/lower A-pillar area through the grommet indicated in the images at right (Figures 3 and 4).

**Tip:** Do *not* route the wire through the same opening used by the existing wire harness.

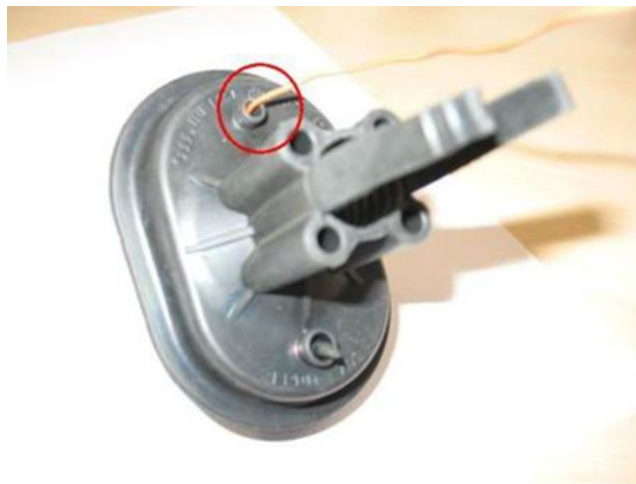
**Figure 4.** Access hole in grommet.

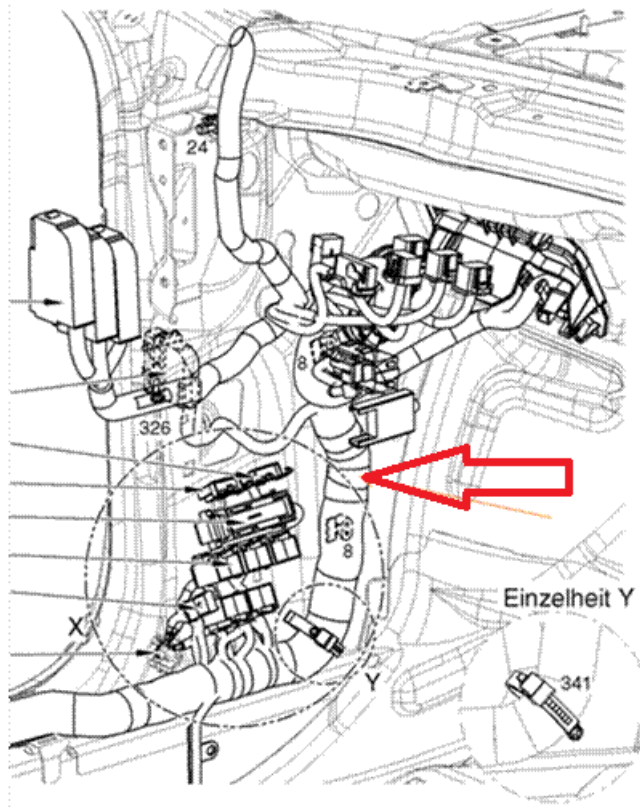
**Figure 5.** Cable routing with charisma switch option.

On vehicles with a charisma switch (ride selection switch located on the instrument panel) route the new cable of the sender for sensor G395 to junction B549 (Figure 5, red arrow).

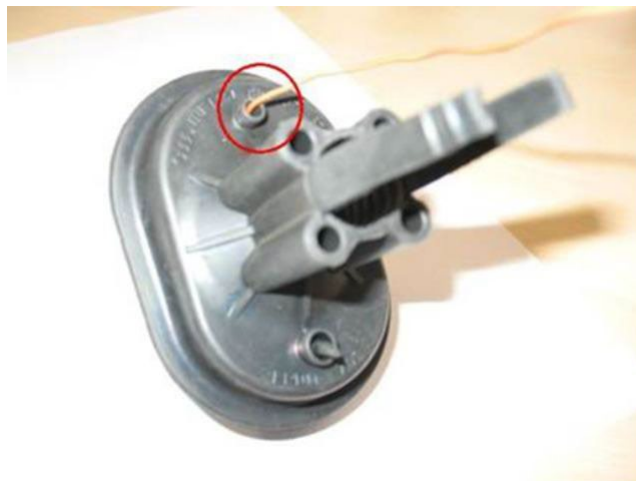
**Figure 6.** Access hole in grommet to be sealed with Butyl sealant.

- b. Seal off the opening around the wire with Butyl sealant to prevent water intrusion (Figure 6).
