**Complaint "Seat cover wrinkled" (22/13)**

Model Line: **All model lines**

Concerns: **Look of the seat cover**

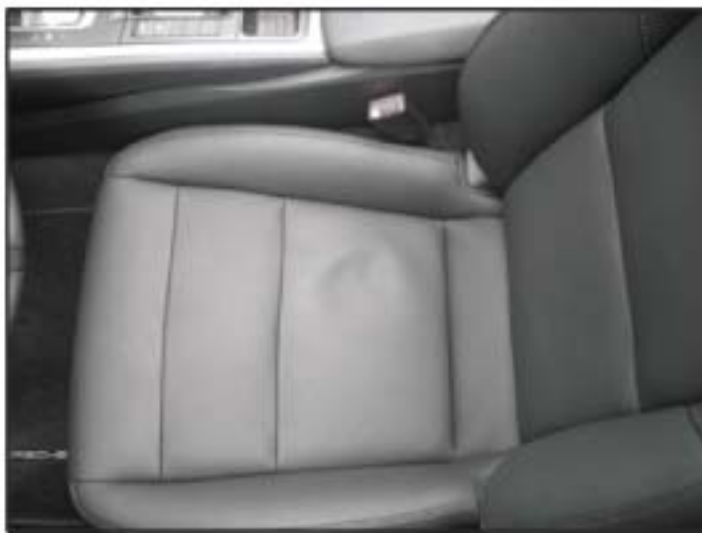
*Figure 1*

If wrinkles or bulges are visible on a seat cover (e.g. ⇒ *Figure 1*), these do not constitute a defect.

- **Automotive upholstery is not cut from the exactly the same location and the exact same orientation on each hide.**
- **This can vary from hide to hide.**
- **The result is that there can be variations between leather upholstered components.**
- **Body heat, perspiration and body weight** cause fabric and leather to **stretch, resulting in "wrinkles"**.

This **visual change is perfectly normal** and does

- **not affect** its use, function or service life
- **and is not a defect.**

⇒ If a visual flaw that is **clearly different** from the "natural characteristics" described here is found, the seat cover must be replaced:

- Sufficient **documentation with corresponding pictures** (clear overview and detailed photos) **must be provided.**
- The **seat cushion is not the cause** of these wrinkles and **must not therefore be replaced.**

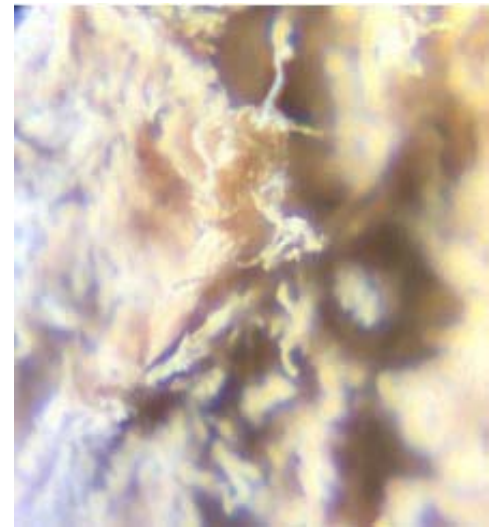
*leather fiber*

- Each hide varies in its composition, strength, flexibility, etc.
- The fibers can stretch and shrink a small amount.
- Stretching beyond this amount breaks bonds between the fibers.
- This stretching is irreversible and is the kind of stretching that body weight, heat and perspiration normally cause. /⇒ Wrinkling, creasing and bulging are results of this kind of normal stretching (as shown in the above photo of the seat).
- The larger the upholstered surface, the greater the tendency to crease and bulge.
