**WRB1 - Replacing Gateway Control Unit (Workshop Campaign)**

Model Line: **Cayenne (9YA / 9YB)**

Model Year: **As of 2023 up to 2024**

Concerns: **Gateway control unit**

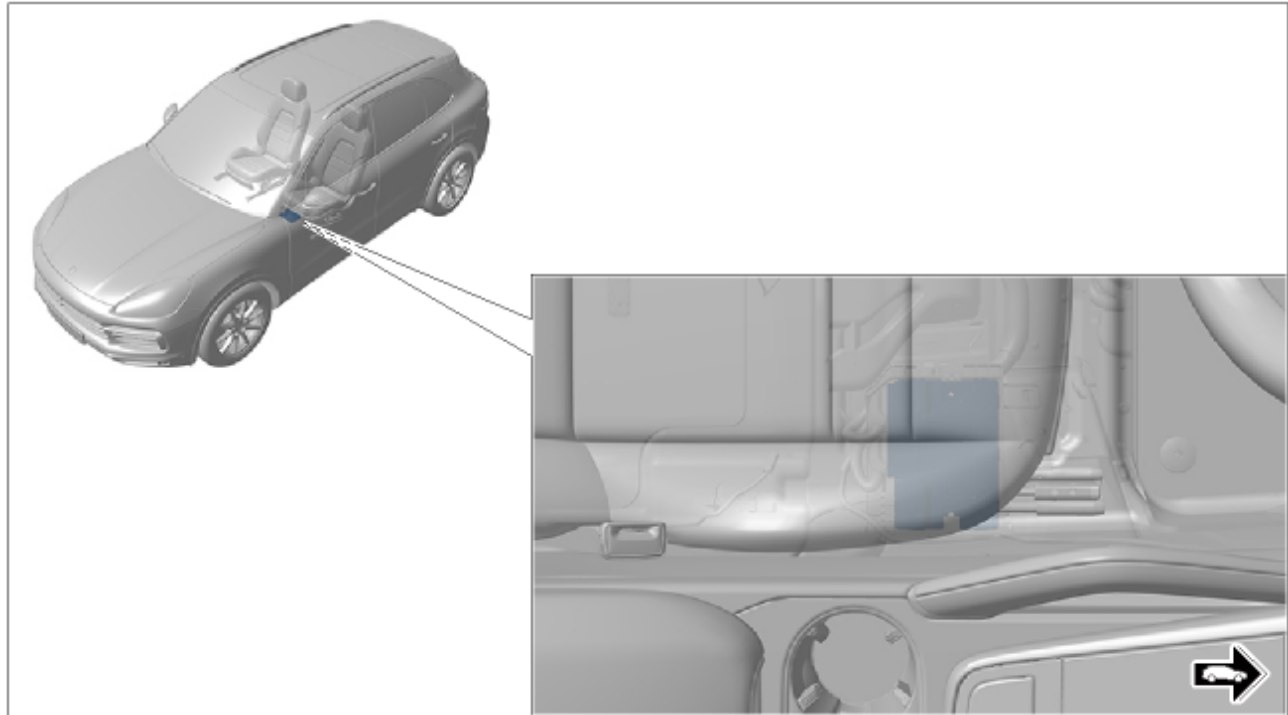
*Installation position of gateway control unit*
