WRB1 - Replacing Gateway Control Unit (Workshop Campaign)

Model Line: **Panamera (971)**

Model Year: **As of 2023 up to 2024**

Concerns: **Gateway control unit**

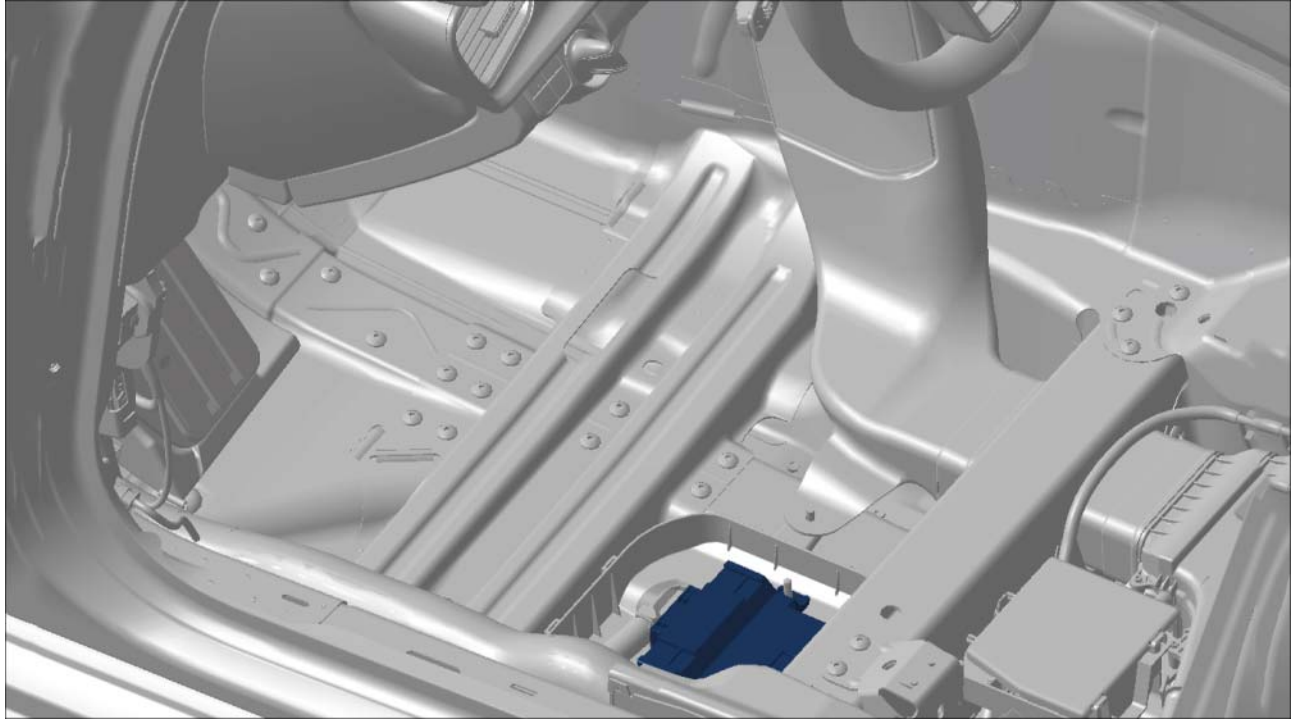
Installation position of gateway control unit

- Work Procedure: 1 Replace the gateway control unit.
For instructions, see:
⇒ *Workshop Manual '903519 Removing and installing gateway control unit'*
⇒ *Workshop Manual '903555 Replacing gateway control unit'*
- 2 Enter the campaign in the Warranty and Maintenance logbook.
