Technical Service Bulletin

91 No diagnostics communication to the telematics control module (ConBox); DTC U142100

91 24 05 2070942/3 April 26, 2024. Supersedes Technical Service Bulletin Group 91 number 23-36 dated October 26, 2023 for reasons listed below.

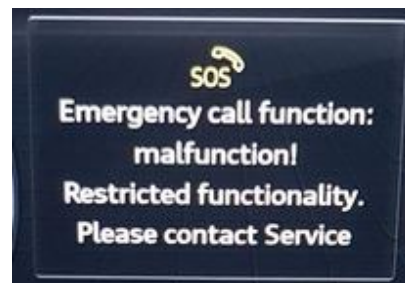
- An SOS Warning might be displayed in the instrument cluster (Figure 1).

Figure 1. Emergency call malfunction warning.

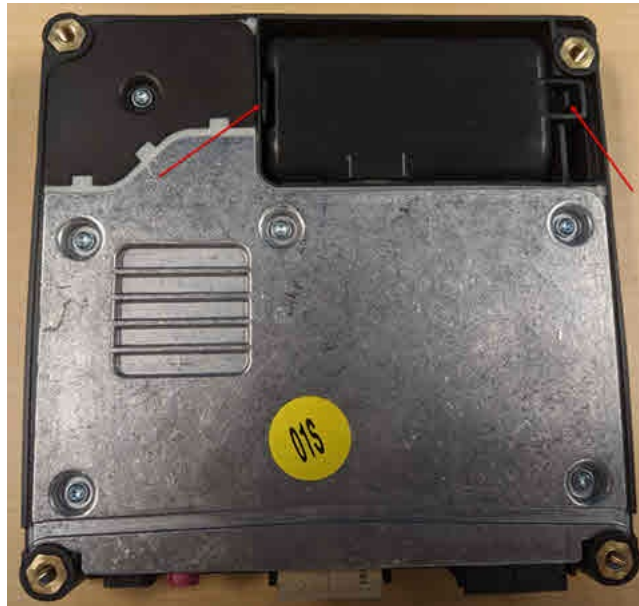
Figure 2. Backup battery compartment location.

2. Open the battery compartment of the control module for the emergency call module and communication unit, -J949- (address word 0075), and disconnect the backup battery (Figures 2 - 3).

3. Wait approximately one minute, then reinstall the backup battery back into the control module for the emergency call module and communication unit, -J949- (address word 0075).
4. Reinstall the control module for the emergency call module and communication unit, -J949- (address word 0075) back into the vehicle.
5. If ODIS **still cannot** connect to the control module for the emergency call module and communication unit, -J949- (address word 0075), then follow the ODIS test plan and replace the control module for the emergency call module and communication unit with the part specified in ETKA.

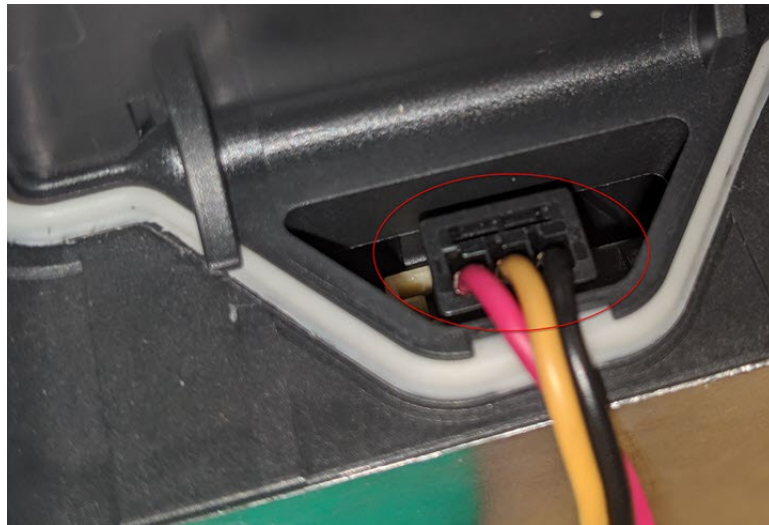
Figure 3. Backup battery connector (no release mechanism).
