TECHNICAL SERVICE BULLETIN

2.7L/3.0L - Illuminated MIL With DTC P25B4, P25B6, And/Or P0299 Stored In The PCM

24-2112
23 April 2024

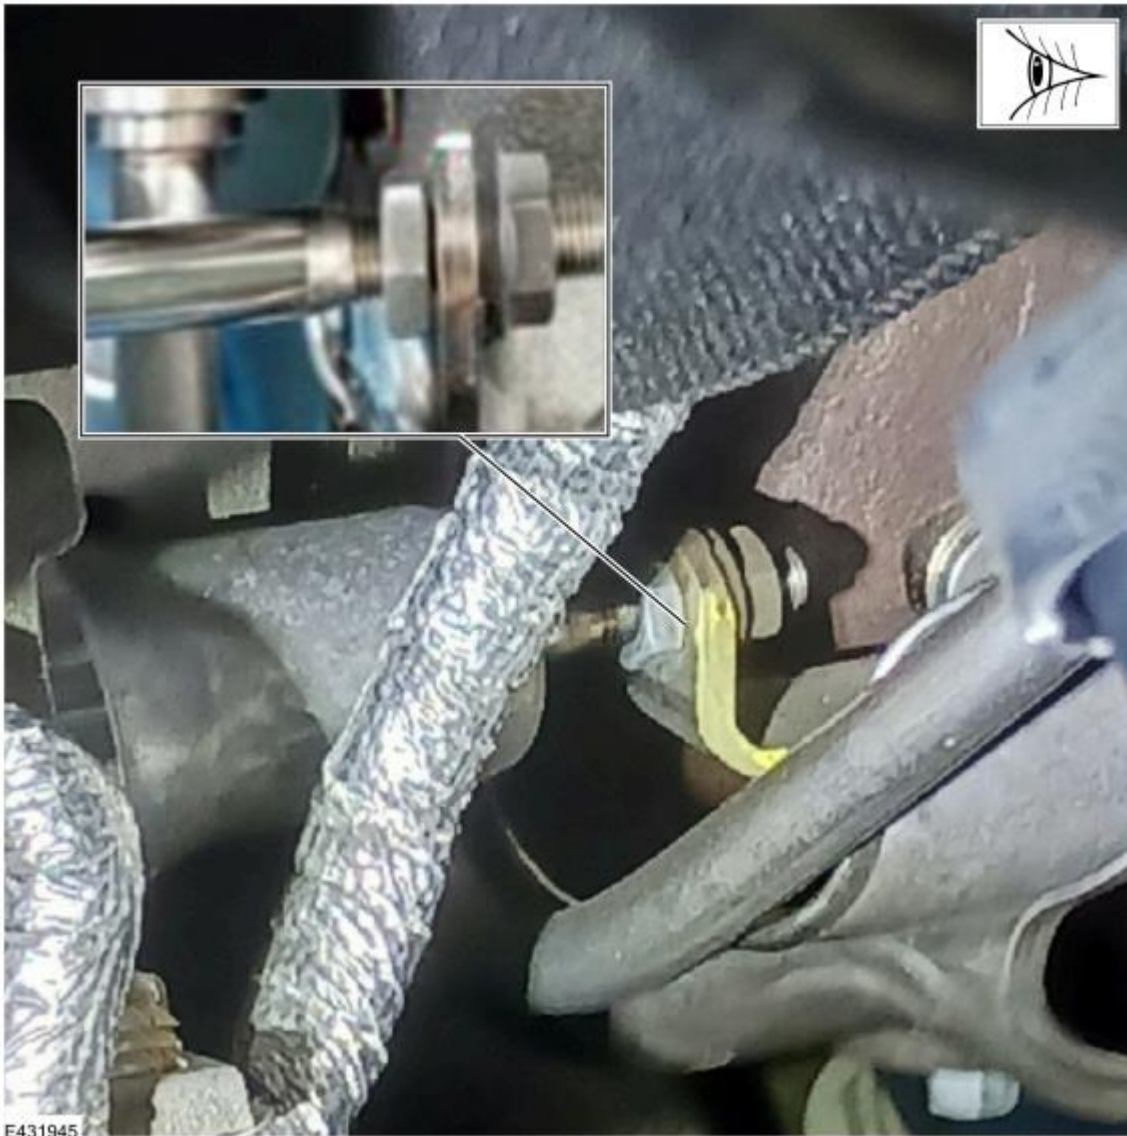
Figure 1

Issue: Some 2021-2023 Bronco vehicles equipped with a 2.7L or 3.0L engine may exhibit an illuminated MIL with DTC P25B4, P25B6, and/or P0299 stored in the PCM. This may be due to a loose nut on the turbo actuator arm causing an under boost condition. To correct the condition, inspect the nut on the turbo actuator arm and repair as necessary.

1. Remove the fender splash shield. Refer to [WSM](#), Section 501-02.
2. If repairing the left turbocharger, remove the heat shield.
 - (1). Tighten the bolts to 89 lb-in (10 Nm).
3. Inspect the turbo actuator arm bolt. Is the turbo actuator arm bolt loose as shown in Figure 1?

- (1). Yes - proceed to Step 4.
 - (2). No - this article does not apply. Refer to normal WSM diagnostics.
4. Tighten the nut. Refer to WSM, Section 303-04 Fuel Charging and Controls > Turbocharger > Removal and Installation > Wastegate Control Acuator - Installation Procedure Steps 1-8.
5. Did this correct the concern?
- (1). Yes - proceed to Step 6.
 - (2). No - refer to WSM for additional diagnostics.
6. Reassemble the vehicle by reversing Steps 1-2.
