Service Bulletin

Bulletin No.: 23-NA-191

Subject: Shake and/or Shudder During Steady Speed and/or Light Throttle Acceleration Between 25 and 50 MPH (40 and 80 KM/H)

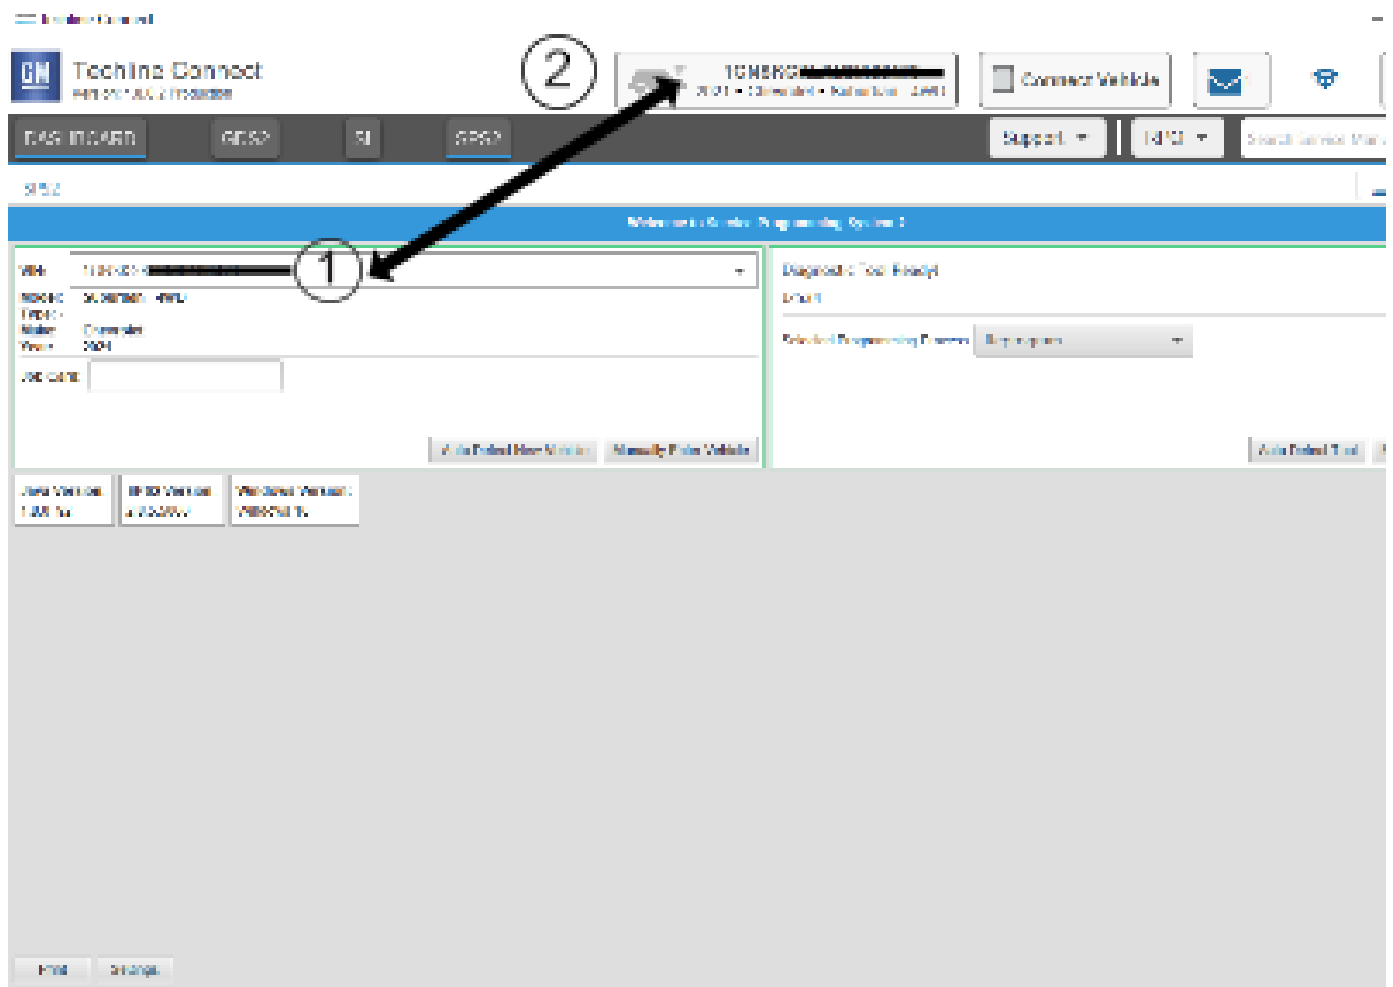
Caution: Be sure the VIN selected in the drop-down menu (1) is the same as the vehicle connected (2) before beginning programming.

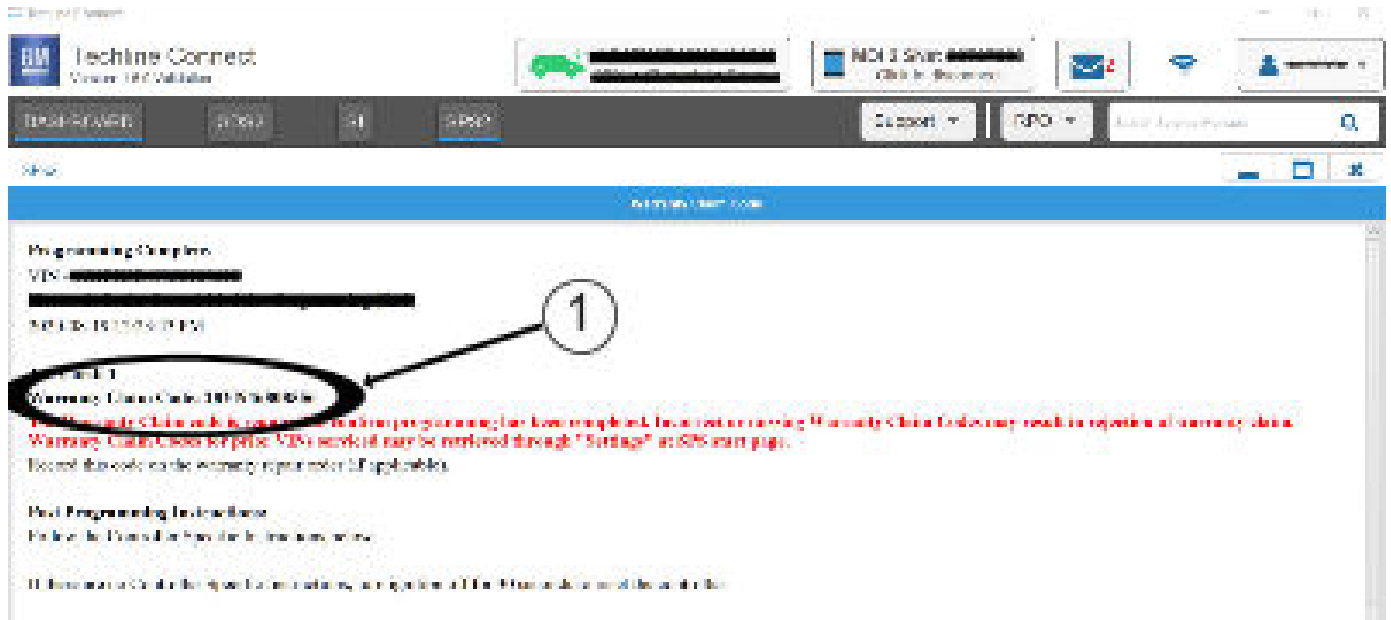
5644478

Important: To avoid warranty transaction rejections, you MUST record the warranty claim code provided on the Warranty Claim Code (WCC) screen shown above on the job card. Refer to callout 1 above for the location of the WCC on the screen.

1. Reprogram the TCM. Refer to *Transmission Control Module Programming and Setup in SI*.

2. Record SPS Warranty Claim Code on job card for warranty transaction submission.
