# Service Bulletin

Bulletin No.: 24-NA-056

**Subject: Radio Software Version W27E-172.5.1-M169-SQBR4-126.4**

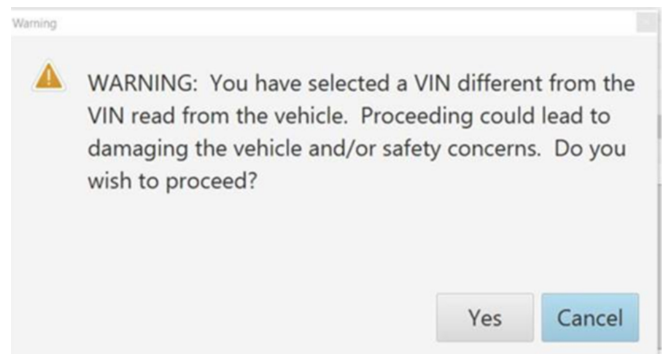
5877000

**Important:** If the vehicle VIN DOES NOT match, the message below will be shown

**Important:** If the same calibration/software warning is noted on the TLC Summary screen, select OK and follow screen instructions. After a successful programming event, the WCC is located in the Service Programming System dialogue box of the SPS Summary screen. No further action is required. Refer to the Warranty section of the bulletin.
