Service Bulletin

Bulletin No.: 08-08-57-003D

Subject: Floor Wet Under Carpet/Engine Continues to Run with Key Off/Possible No Crank/No Start/Communication Loss/Various Electrical Concerns (Seal Seam)

Models: 2008-2012 Buick Enclave
2009-2012 Chevrolet Traverse
2007-2012 GMC Acadia
2007-2010 Saturn OUTLOOK

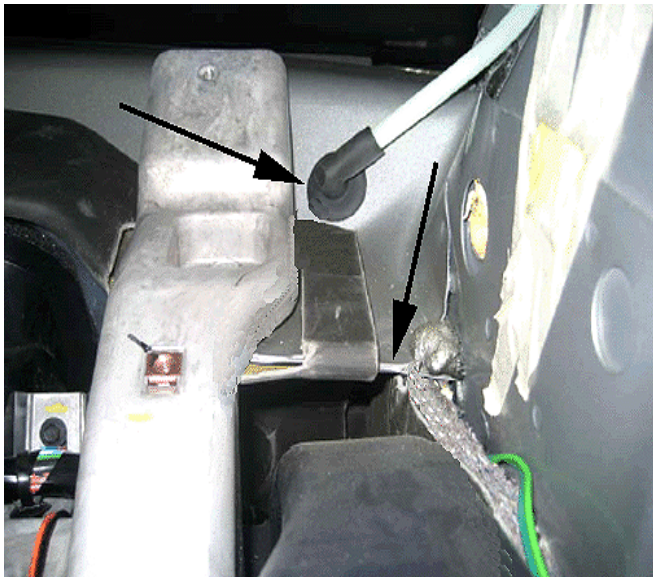
2125552

Water from the right front sunroof drain hose exits the vehicle through the plenum (upper arrow) and may re-enter through the un-sealed seam at the front of the dash. Refer to lower arrow in the illustration.
