Service Bulletin

Bulletin No.: PIT4898C

Subject: The Drivers Power Seat Inoperative or SIR Light Is On With DTCs B0014 B0015 B0021

Models: 2010 Chevrolet Equinox

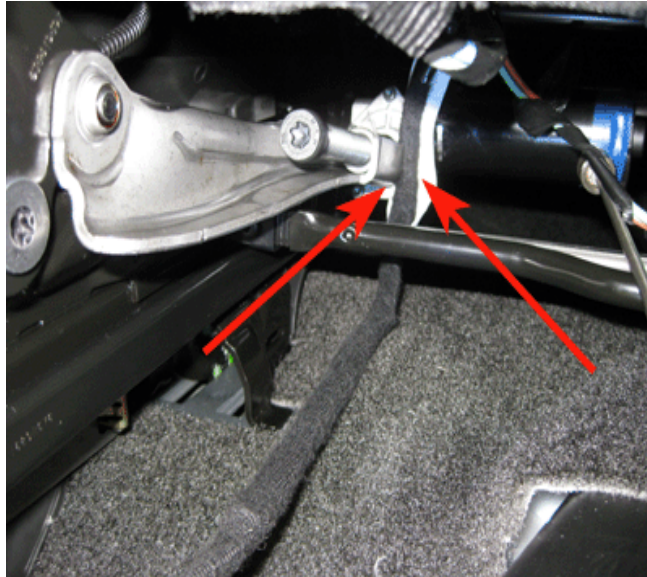
2321545

In rare cases, customers may complain that the driver's power seat is inoperative and/or the SIR light is coming on intermittently. When diagnosing the vehicle, DTC's B0014 and/or B0015 may be found in the SDM. The "PWR SEAT LT" fuse may be open in the underhood fuse block. This may be caused by a wire harness getting pinched under the driver's seat, between the seat frame and the power seat motor (see picture above). This concern happens when the seat is moved to the up position. This is applicable for both 4 and 8 way power seats.

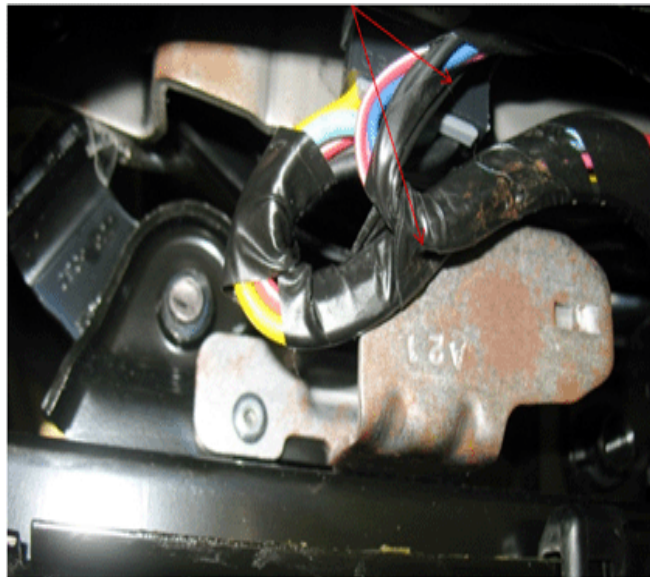
2526551

On vehicles equipped with 4 way seats, driver's side seat wiring to switch can become pinched and/or chafe on side shield bracket. This can add more pressure from the harness to the seat switch and damage the seat switch. This condition occurs when the seat is in the full down position.

Add abrasion tape and/or wiring conduit to harness in this area. Additionally, file burr smooth.

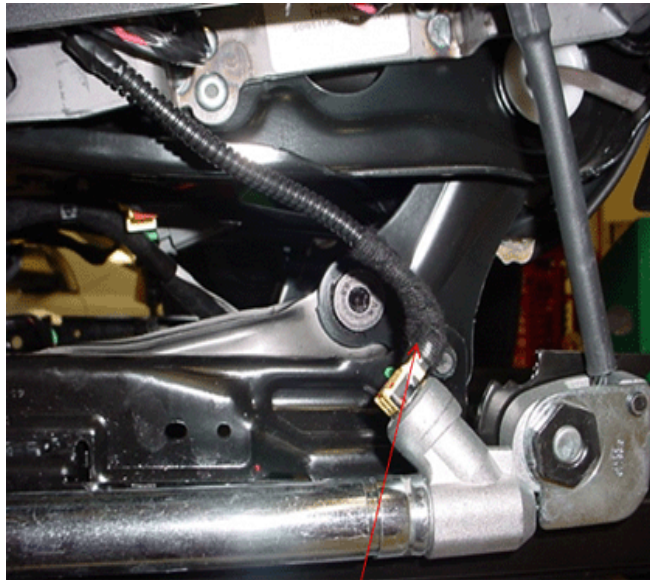
2526555

Driver side 8 way power seat pre-tensioner branch/connection in tension when seat is in full up position. May cause air bag code to set. Tension at connector may cause broken/pulled out wires at connector

Reposition the wire harness branch 10mm to 20mm for more slack.

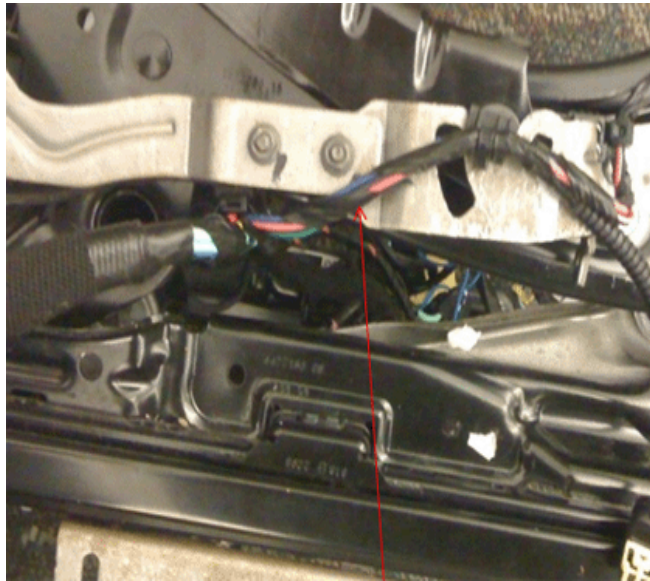
2526558

Pretensioner/Lumbar branch on drivers side 8 way power seat may become pinched or trapped under outboard side bracket.

Add conduit or equivalent protective covering wire harness
