Outside door handle does not return to end position

Topic number	LI72.00-P-053016
Version	1
Design group	72.00 General
Date	01-18-2012
Validity	W166
Reason for change	
Reason for block

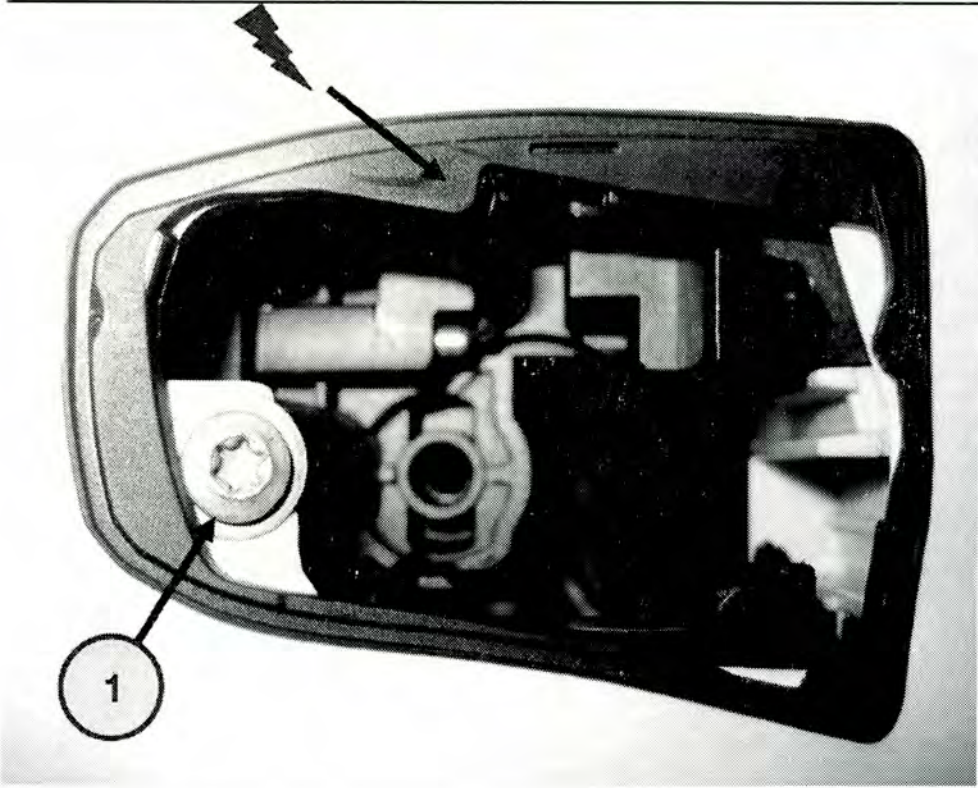
Bild1.jpg:

Incorrectly installed shim between outside door handle and door shell cutout.

Attachments	
File	Designation
Bild1.jpg	Incorrectly positioned shim
Bild2.jpg	Correctly positioned shim

1. Remove door handle.
2. Loosen bolt of bearing bracket, see item 1, Figure 1.
3. Push bearing bracket towards the rear of the vehicle as far as the stop and retighten bolt.
3. Check position of shim in door and correct if necessary, see Figure 1 and Figure 2.
4. Install door handle.
5. Perform function test.
