### Outside door handle no longer returns to end position

Topic number	LI72.00-P-048483
Version	1
Design group	72.00 General
Date	12-03-2009
Validity	Model series 164 from VIN end no.: 298 504 up to VIN end no.: 407 859 Model series 251 from VIN end no.: 062 281 up to VIN end no.: 083 326
Reason for change	Remedy updated / Supersedes DTB T-B-72.00/100c
Reason for block

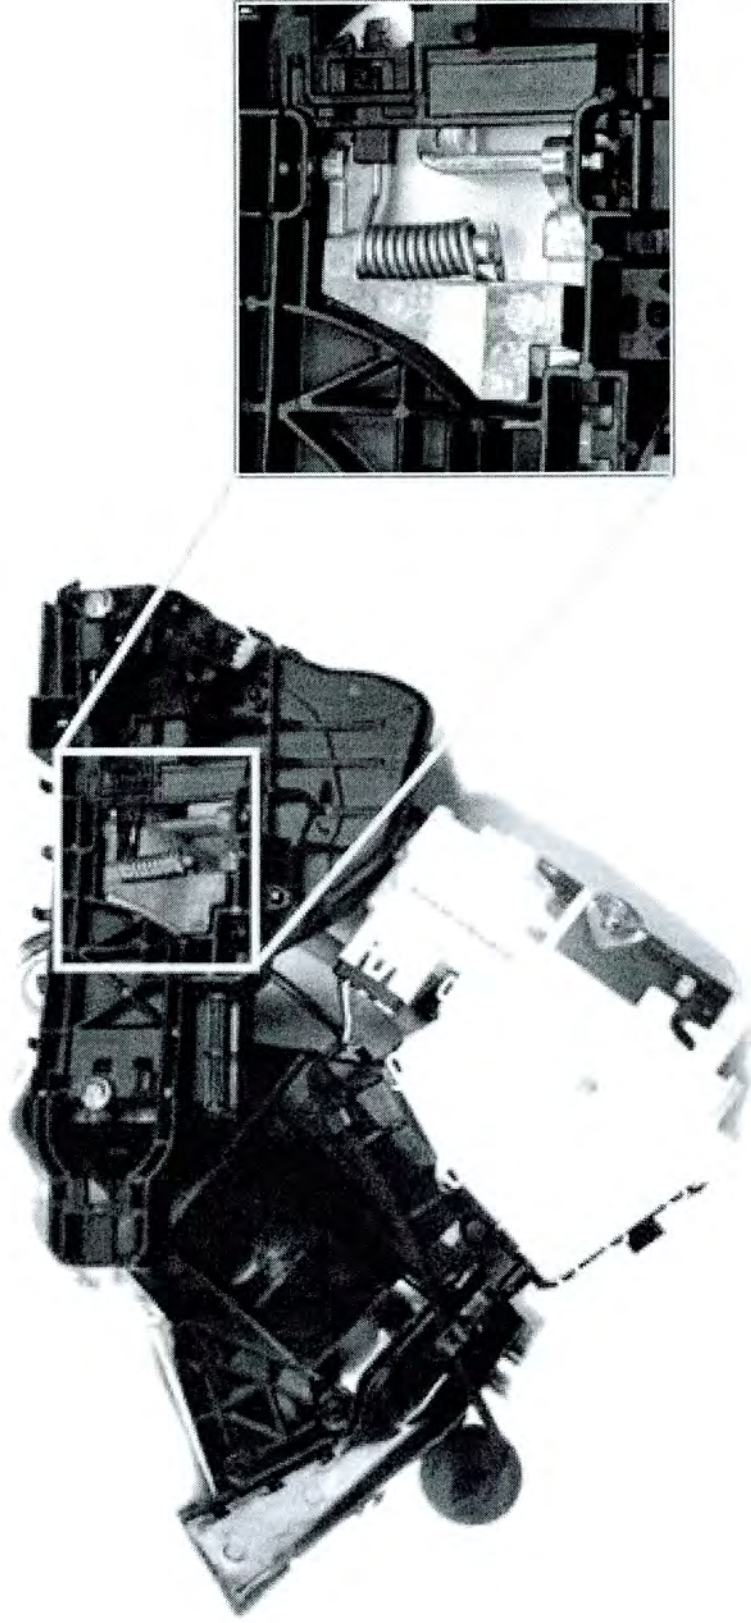
## 1. Ist-Situation

Due to a bent pin in the dynamic balancer, the support spring of the bearing bracket can slide out of place or become unhooked.
