Outside door handle no longer returns to end position

Topic number	LI72.00-P-048483
Version	2
Design group	72.00 General
Date	11-05-2010
Validity	Model series 164 from VIN end no.: 298 504 up to VIN end no.: 407 859 Model series 251 from VIN end no.: 062 281 up to VIN end no.: 083 326
Reason for change	Notes within Remedy section updated regarding wording "process all four door handles".
Reason for block

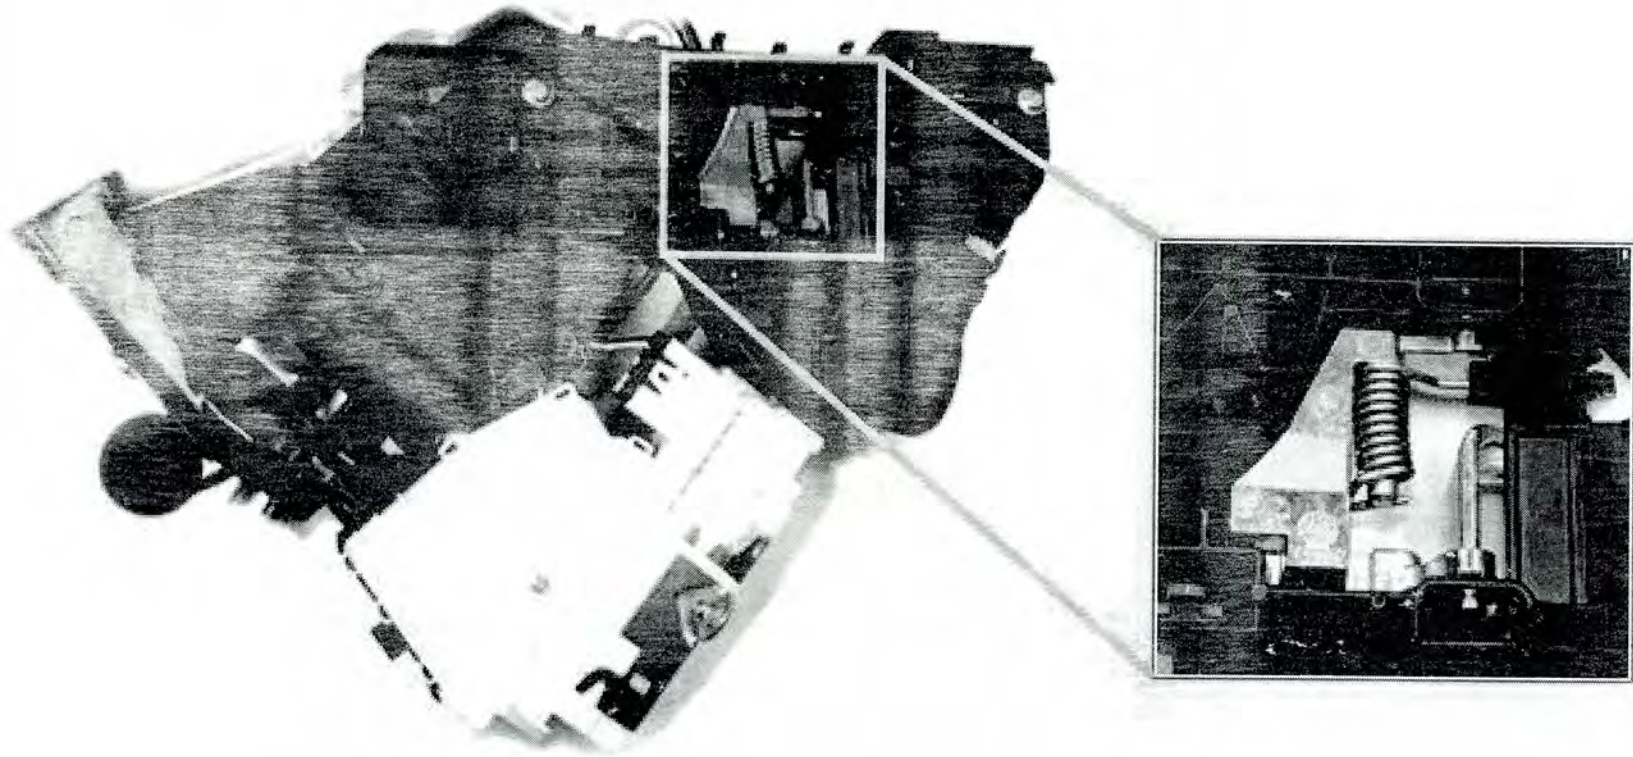
1. Ist-Situation

The outside door handle on the front door or rear door no longer returns automatically to the end position after actuation.

Due to a bent pin in the dynamic balancer, the support spring of the bearing bracket can slide out of place or become unhooked.
