Service Bulletin

Bulletin No.: PIT4632C

Subject: Click Or Clunk Noise From The Steering Column When Turning

Models: 2008 - 2009 Buick Enclave
2009 Chevrolet Traverse
2007 - 2009 GMC Acadia
2007 - 2009 Saturn Outlook
With RPO N37

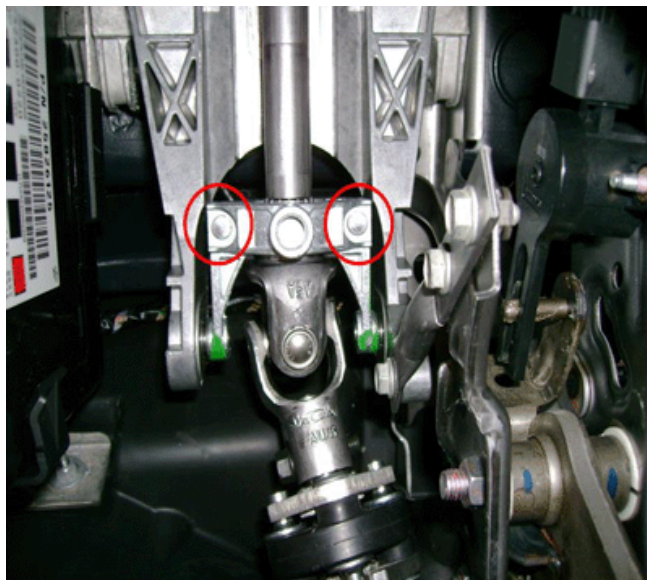
2106249

Some customers may comment on a clunk or click noise from the steering column area when turning the steering wheel. This concern may be duplicated by turning the steering wheel back and forth.

This may be caused by a loose rivet on the lower steering column support bearing cap. See picture above.

Inspect the lower steering column support bearing bracket for a loose rivet. If a loose rivet is found, it will be necessary to replace the steering column.

If there are no rivets on the lower steering column support bearing cap it has a newer column, follow normal diagnostics.
