Service Bulletin

Bulletin No.: PIT4632B

Subject: Click Or Clunk Noise From The Steering Column When Turning

Models: 2008 - 2012 Buick Enclave
2009 - 2012 Chevrolet Traverse
2007 - 2012 GMC Acadia
2007 - 2010 Saturn Outlook
With RPO N37

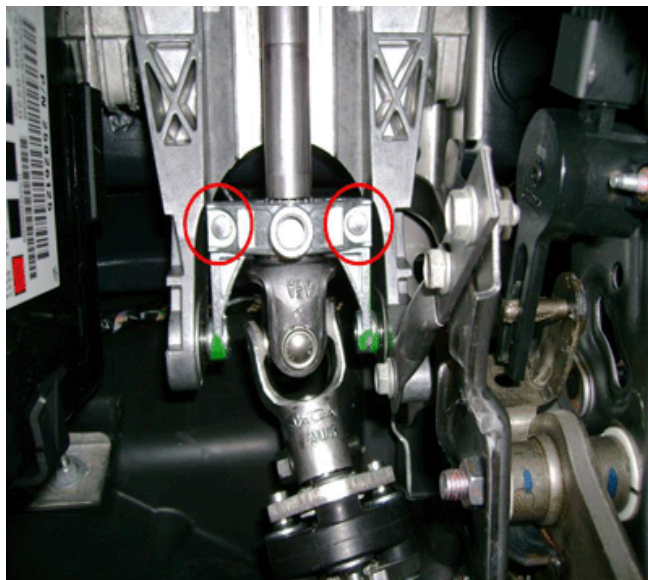
2106249

This may be caused by a loose rivet on the lower steering column support bearing cap. See picture above.

Inspect the lower steering column support bearing bracket for a loose rivet. If a loose rivet is found, it will be necessary to replace the steering column.
