Bulletin No.: PIT4632A

Subject: Click or Clunk Noise From The Steering Column When Turning

Models: 2008-2010 Buick Enclave
2009-2010 Chevrolet Traverse
2007-2010 GMC Acadia
2007-2010 Saturn Outlook
With RPO N37

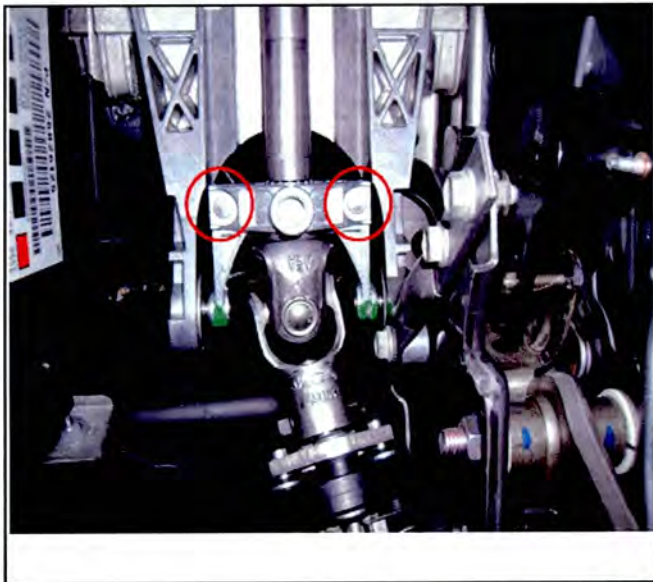
2106249

This may be caused by a loose rivet on the lower steering column support bearing cap. See picture above.

Inspect the lower steering column support bearing bracket for a loose rivet. If a loose rivet is found, it will be necessary to replace the steering column.
