This Service Information bulletin supersedes SI B12 21 10 **dated September 2010.**

NEW N51 Engine: Service Engine Soon Lamp Illuminated - Loss of Power and Various Faults Stored in the DME

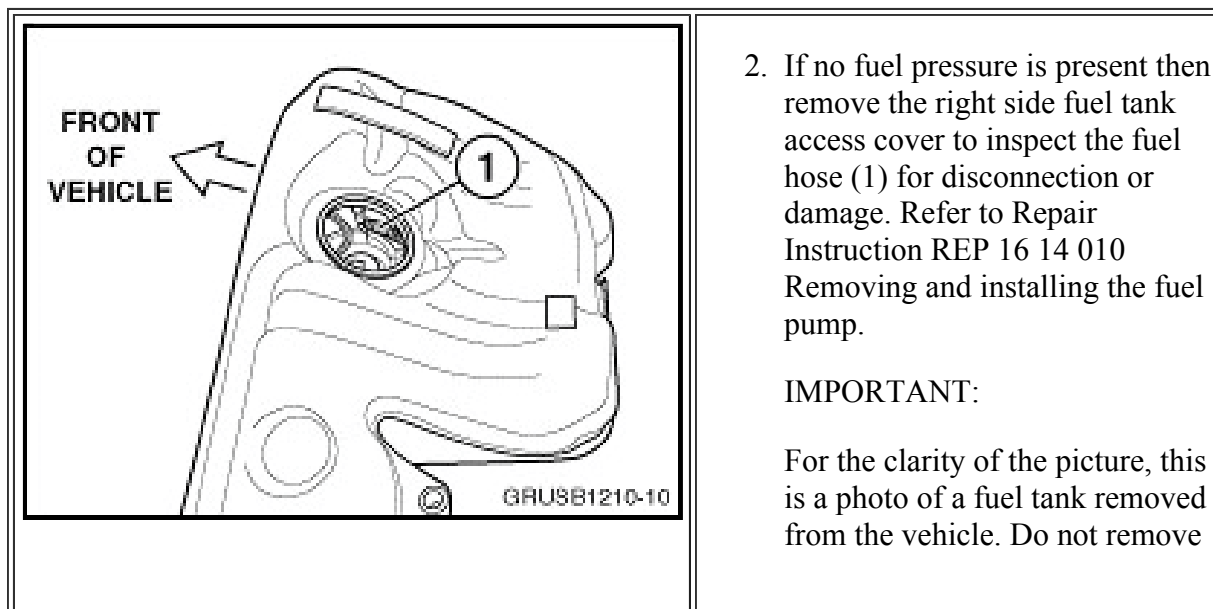
2. If no fuel pressure is present then remove the right side fuel tank access cover to inspect the fuel hose (1) for disconnection or damage. Refer to Repair Instruction REP 16 14 010 Removing and installing the fuel pump.

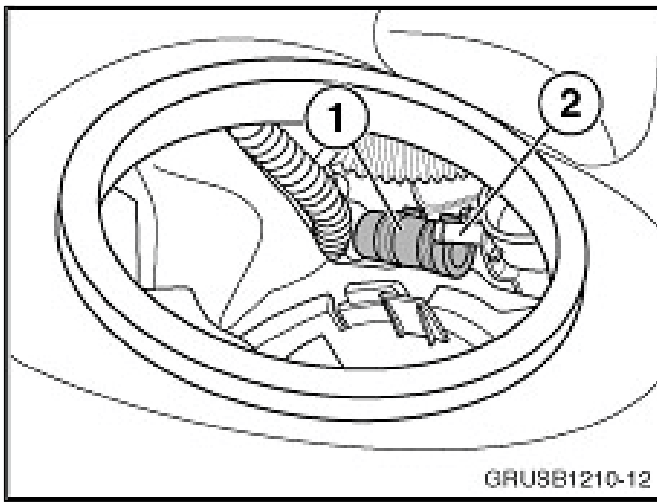
The vehicle has lost fuel system delivery pressure due to a loose or split fuel line inside the fuel tank. The failure is related to an unfavorable stacking of tolerances between the rubber fuel hose and the plastic regulator nipple or deterioration of the rubber hose construction material.

3. Inspect the fuel hose connection (1) on the pressure regulator (2). If the fuel hose is found to be disconnected from the fuel pressure regulator, replace the fuel tank. Do not attempt to replace or re-secure the fuel hose inside the fuel tank.

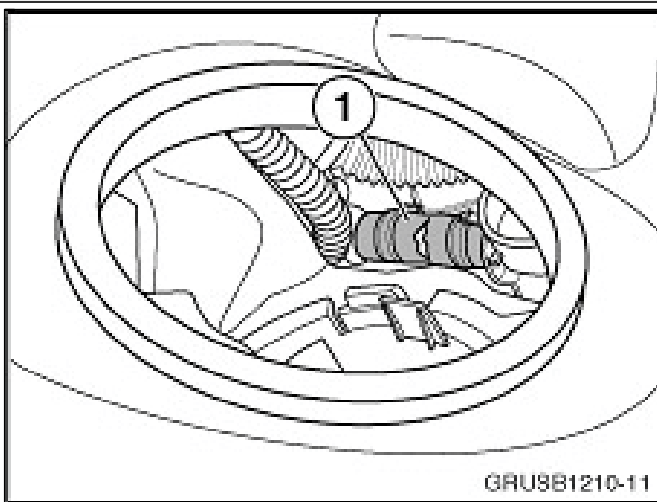
4. Inspect the fuel hose (1) for splitting. It might be necessary to inspect the entire circumference of the fuel hose with a small mirror. If the fuel hose (1) is found to be split, replace the fuel tank. Do not attempt to replace or re-secure the fuel hose inside the fuel tank.
